Conservation of Historic Timber Structures

An ecological approach

Knut Einar Larsen & Nils Marstein

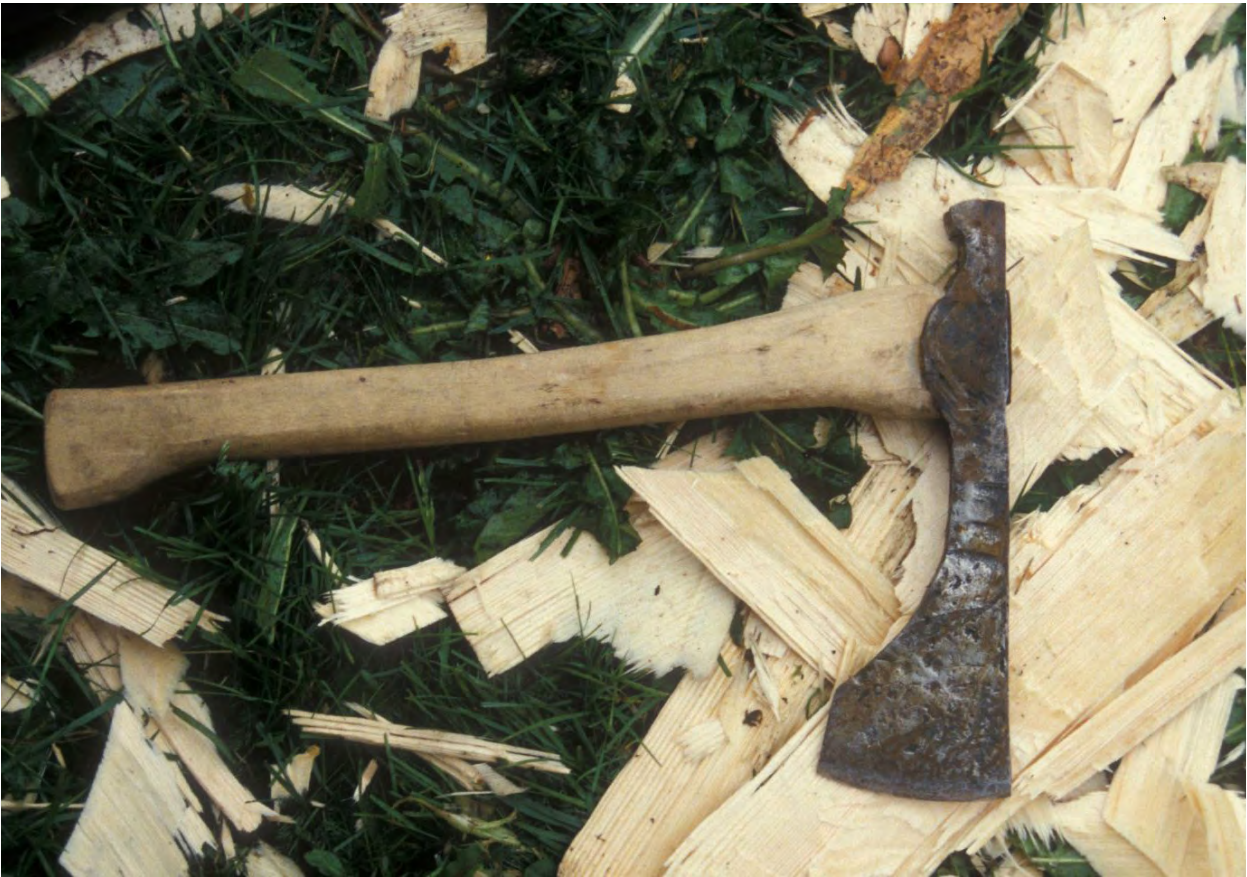
Figure 1.2 A carpenter's axe used for "sprett-telgjing".

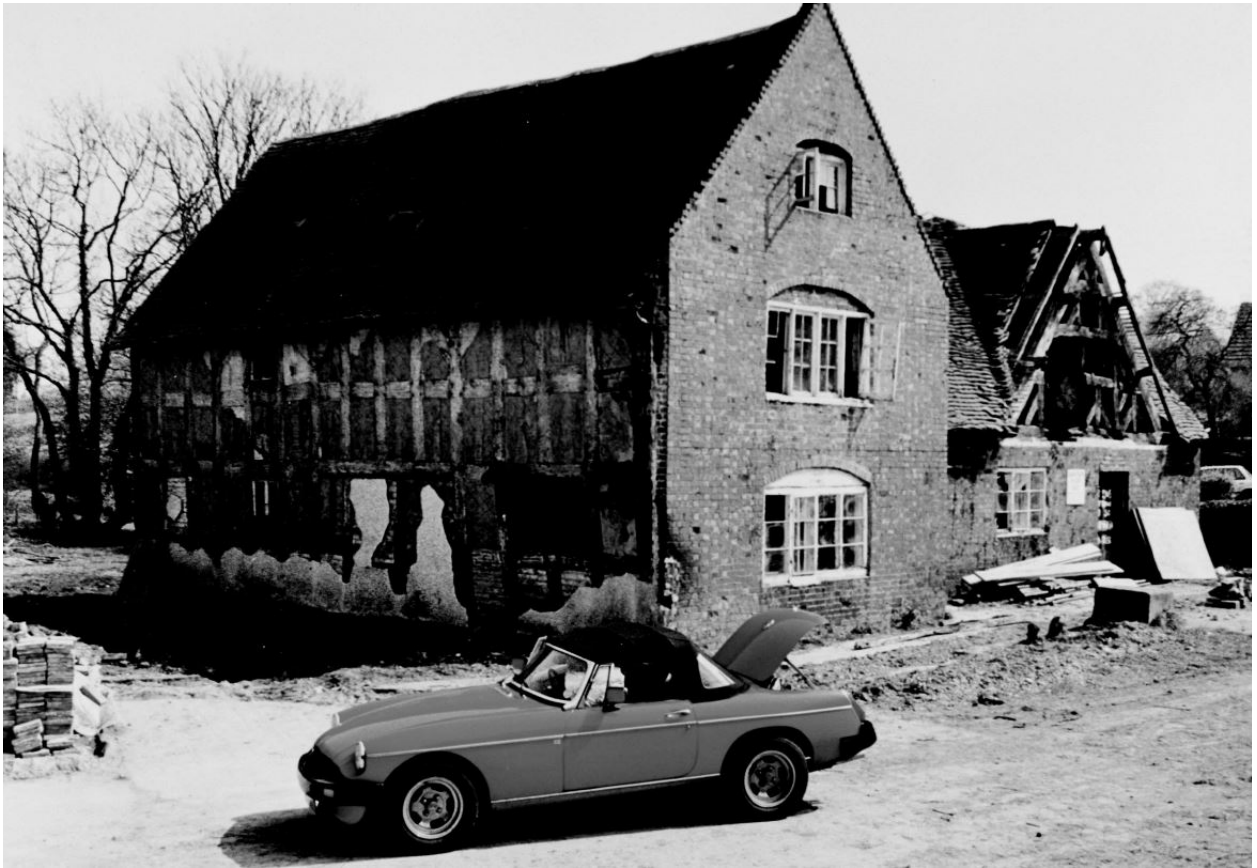
Figure 2.1 Brookgate Hall, Plealey, is one of the oldest manor houses on the Shropshire border between England and Wales. The earliest part was built in 1350. In 1500 a wing was added. In 1612, part of the medieval structure was destroyed and a new parlour built. Photo before the restoration 1987-1990 by the architect and owner, Graham Moss. The house had been empty for several years, the roofs were leaking and the house was in a bad state of repair. (Photo by Graham Moss).

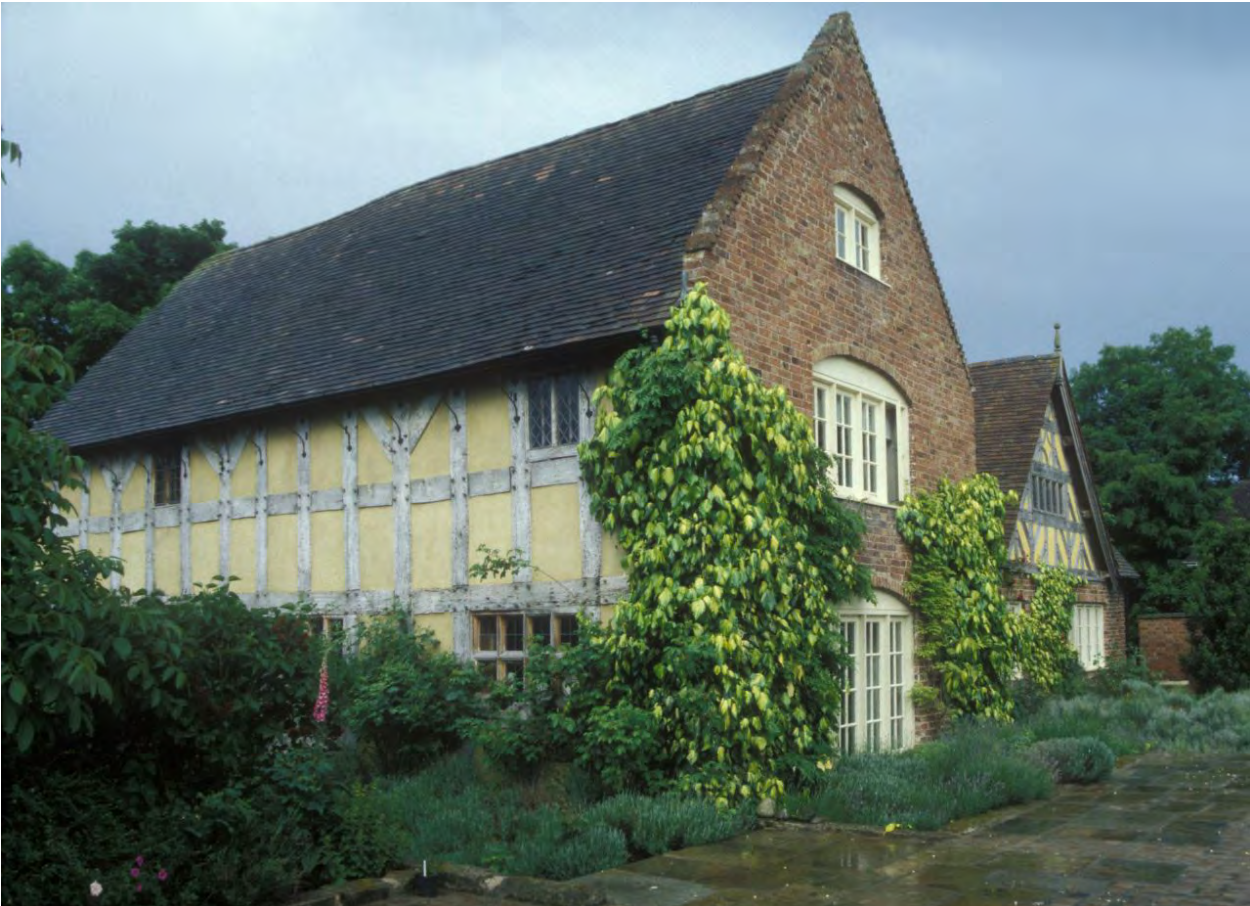
Figure 2.2 Brookgate Hall after restoration. Using the principle of minimum intervention, the architect conserved the timber structure and skilfully rebuilt the house to modern standards while retaining its historic atmosphere.

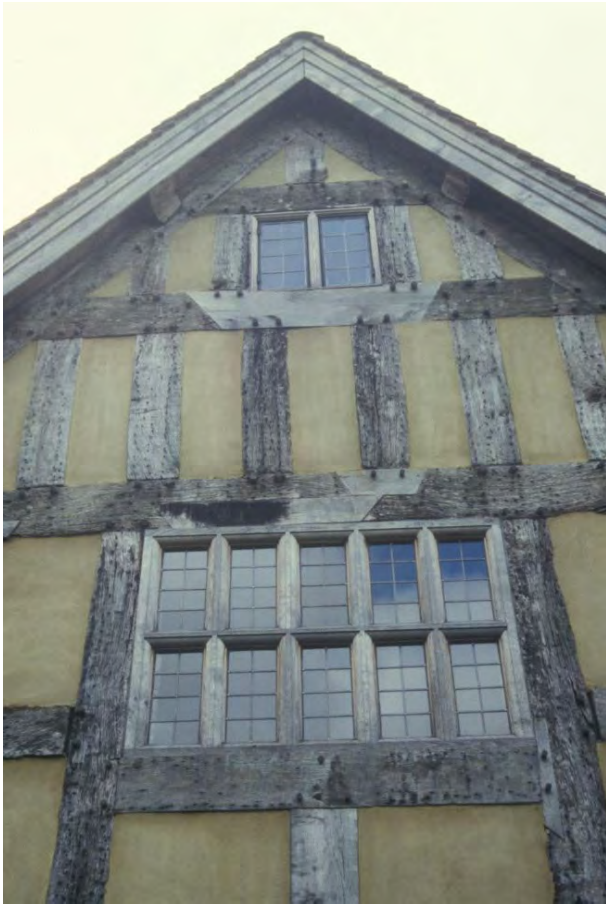
Figure 2.3 Brookgate Hall after restoration. Detail of a gable showing replaced timber in the frame. Brookgate Hall after restoration. Detail of a gable showing replaced timber in the frame.

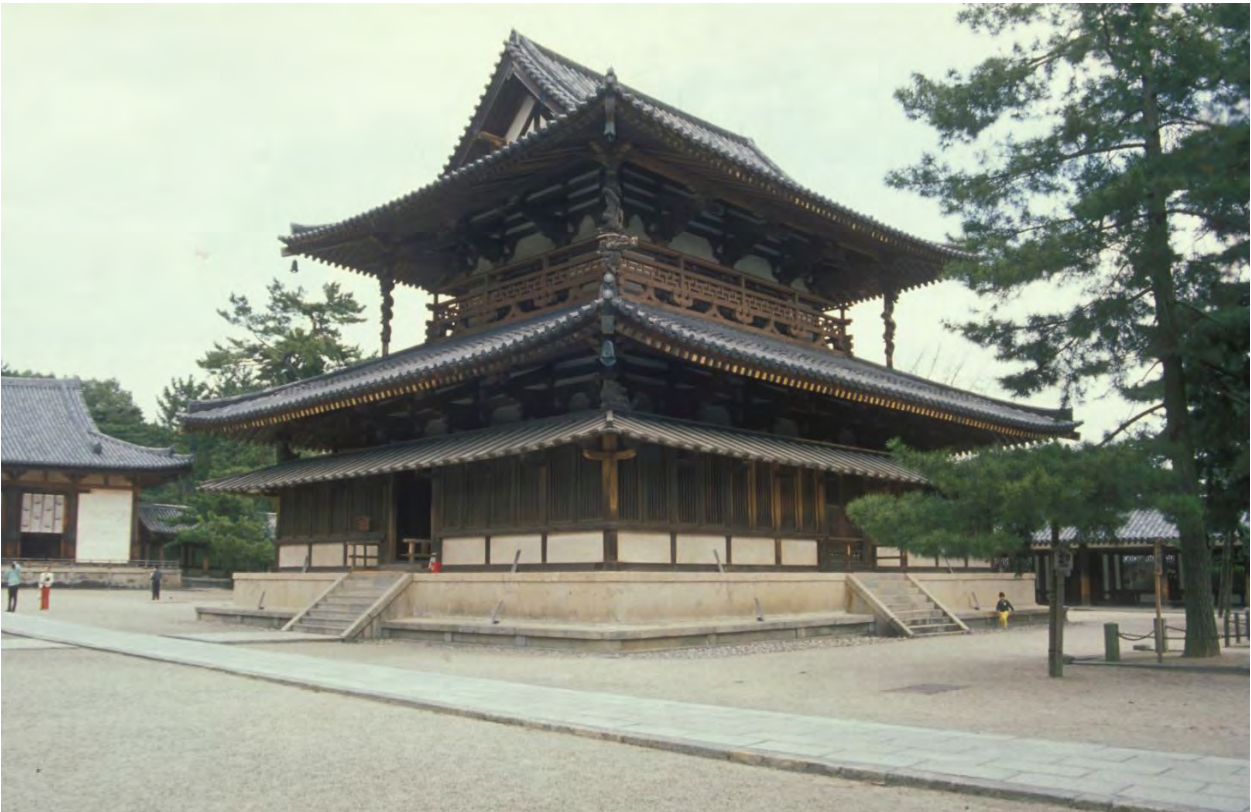
Figure 2.6 The Golden Hall (Kondo) of the Horyu-ji Buddhist temple in Nara, Japan—a World Heritage Site. Built in the late seventh century, this is the oldest timber structure in the world.

Of the upper part of the restored hall standing in the Horyu-ji compound today, some members are original, dating from the seventh century, but many have also been replaced, as the structure was completely dismantled, repaired and reassembled at the beginning of the twelfth century, in 1374 and in 1603. Probably no more than fifteen to twenty per cent of the original materials exist in the present Horyu-ji Kondo.

Before the rebuilding of the present hall could start, the burnt lower part had to be removed. The charred surface of the members was extremely fragile and was consolidated using a synthetic resin; then the structure was carefully dismantled, and finally rebuilt within a fireproof concrete warehouse on the temple site. No new additions were made; the building stands inside the warehouse as a fragment, a ruin. Therefore, the world's oldest wooden building is in reality today two buildings. The burnt one is continuous in form and substance, although a fragment; the hall with its contemporary sacred functions is partially continuous in materials, and also only partially continuous in design, since it was restored to its original design from the seventh century. It must suffice to conclude here that this is a rare case, but still it can be regarded as an example of what may happen to timber structures which burn readily. A fire may lead either to the complete loss of the materials, or they may be so badly damaged that it is not possible to reuse them in reconstruction.

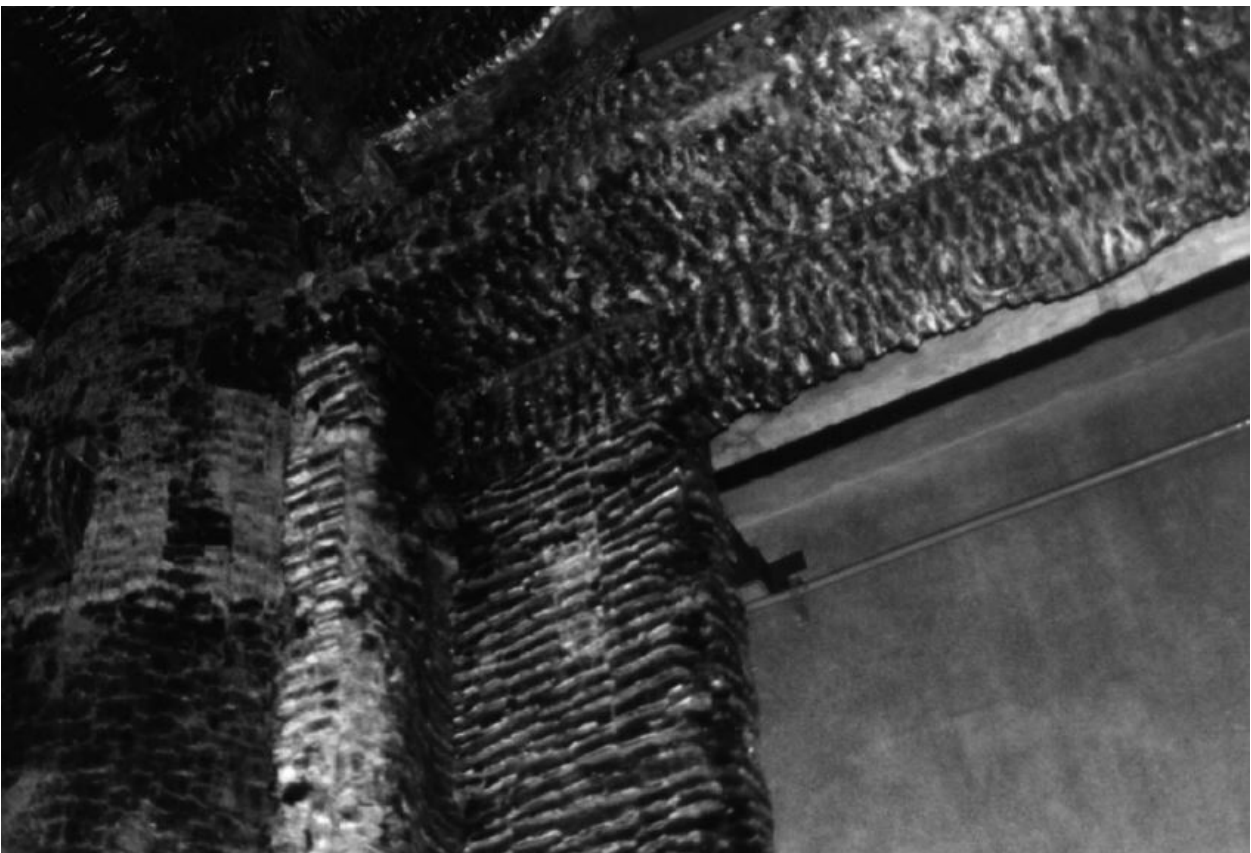
Figure 2.7 The Golden Hall of Horyu-ji. Members from the lower part of the temple hall which were damaged by fire in 1949. These are conserved and exhibited inside a fire-proof warehouse adjacent to the original site.

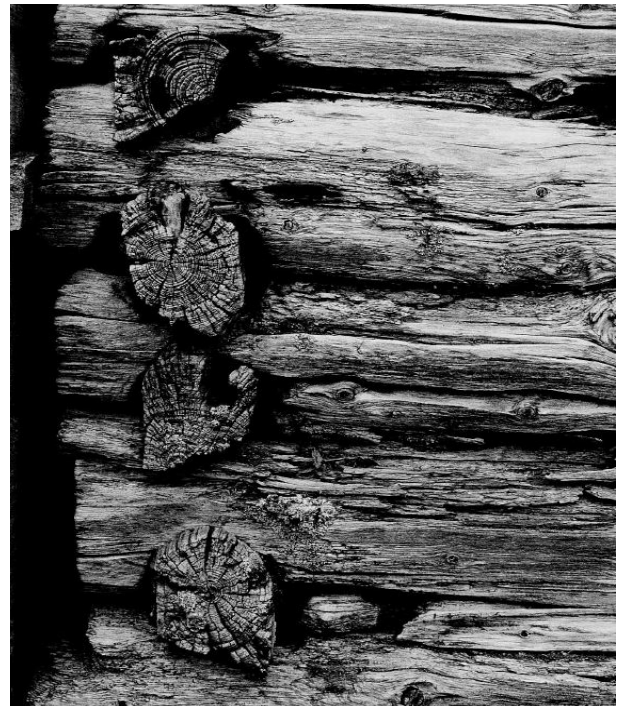
Figure 3.2 Decayed timber in a nineteenth-century boathouse from Misvær, northern Norway.

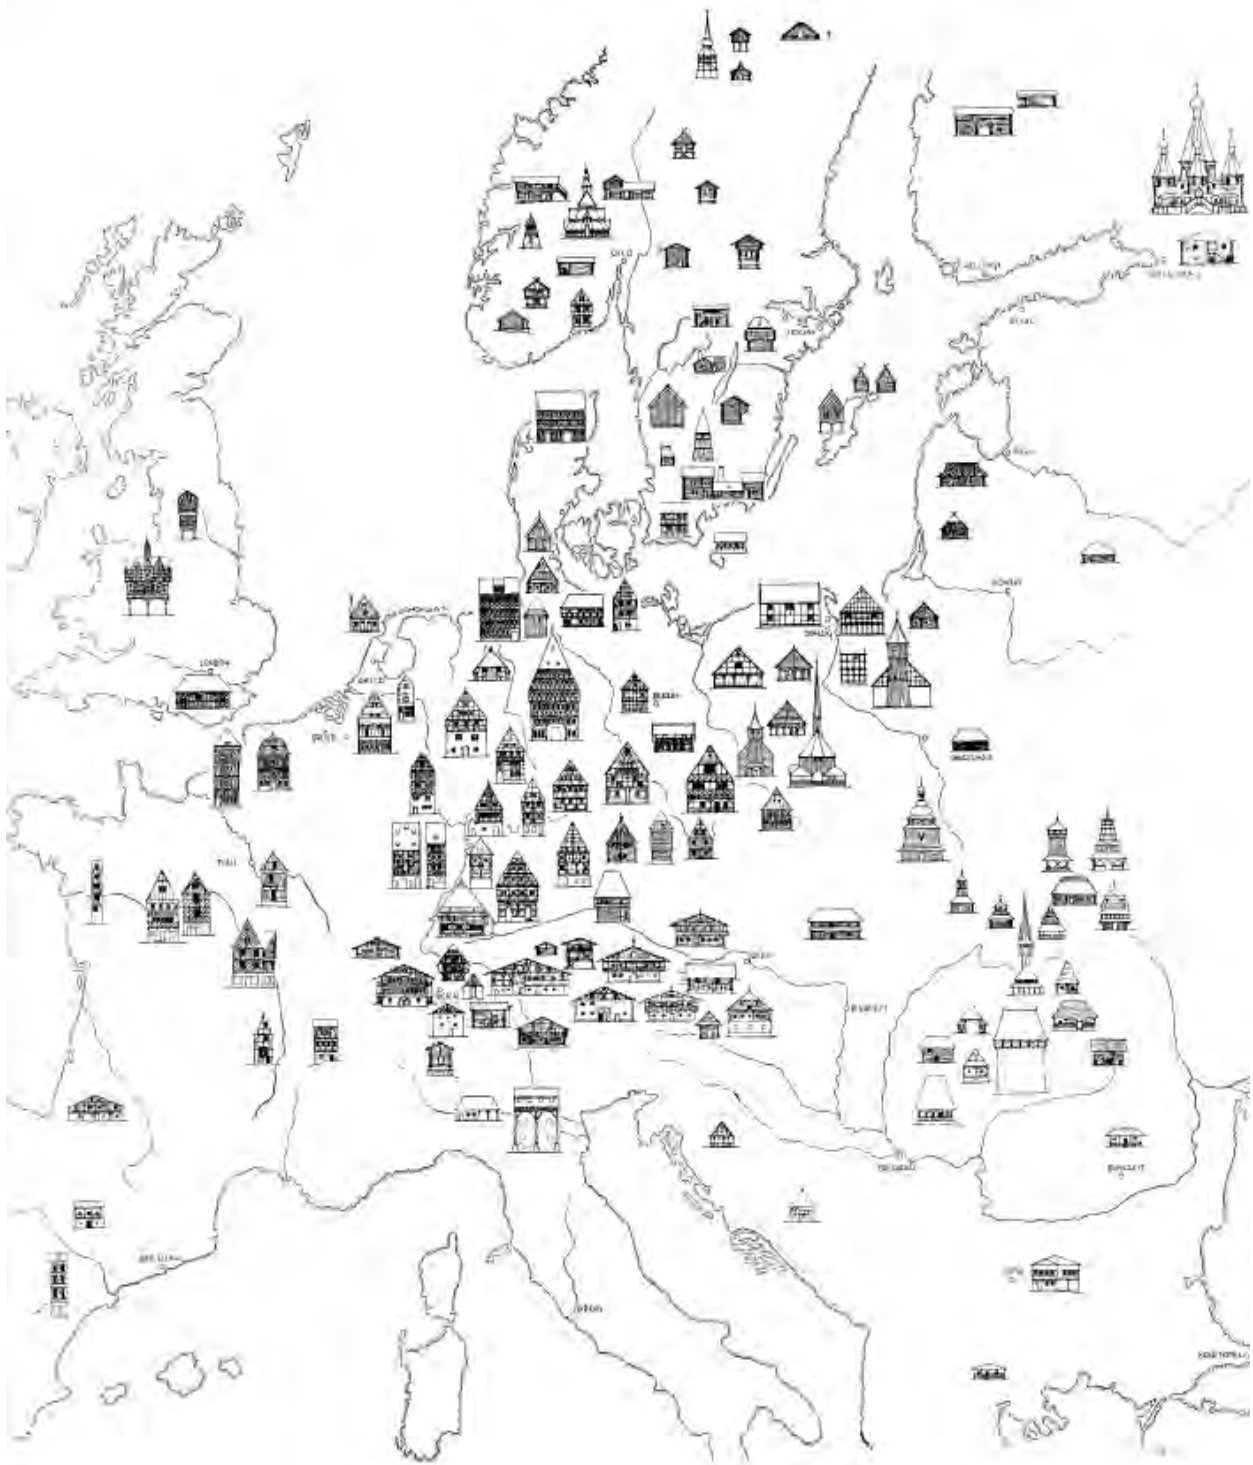
Figure 3.6 Map showing the distribution of the various types of timber structures in Europe. (Drawing from Phelps 1942: 5.)

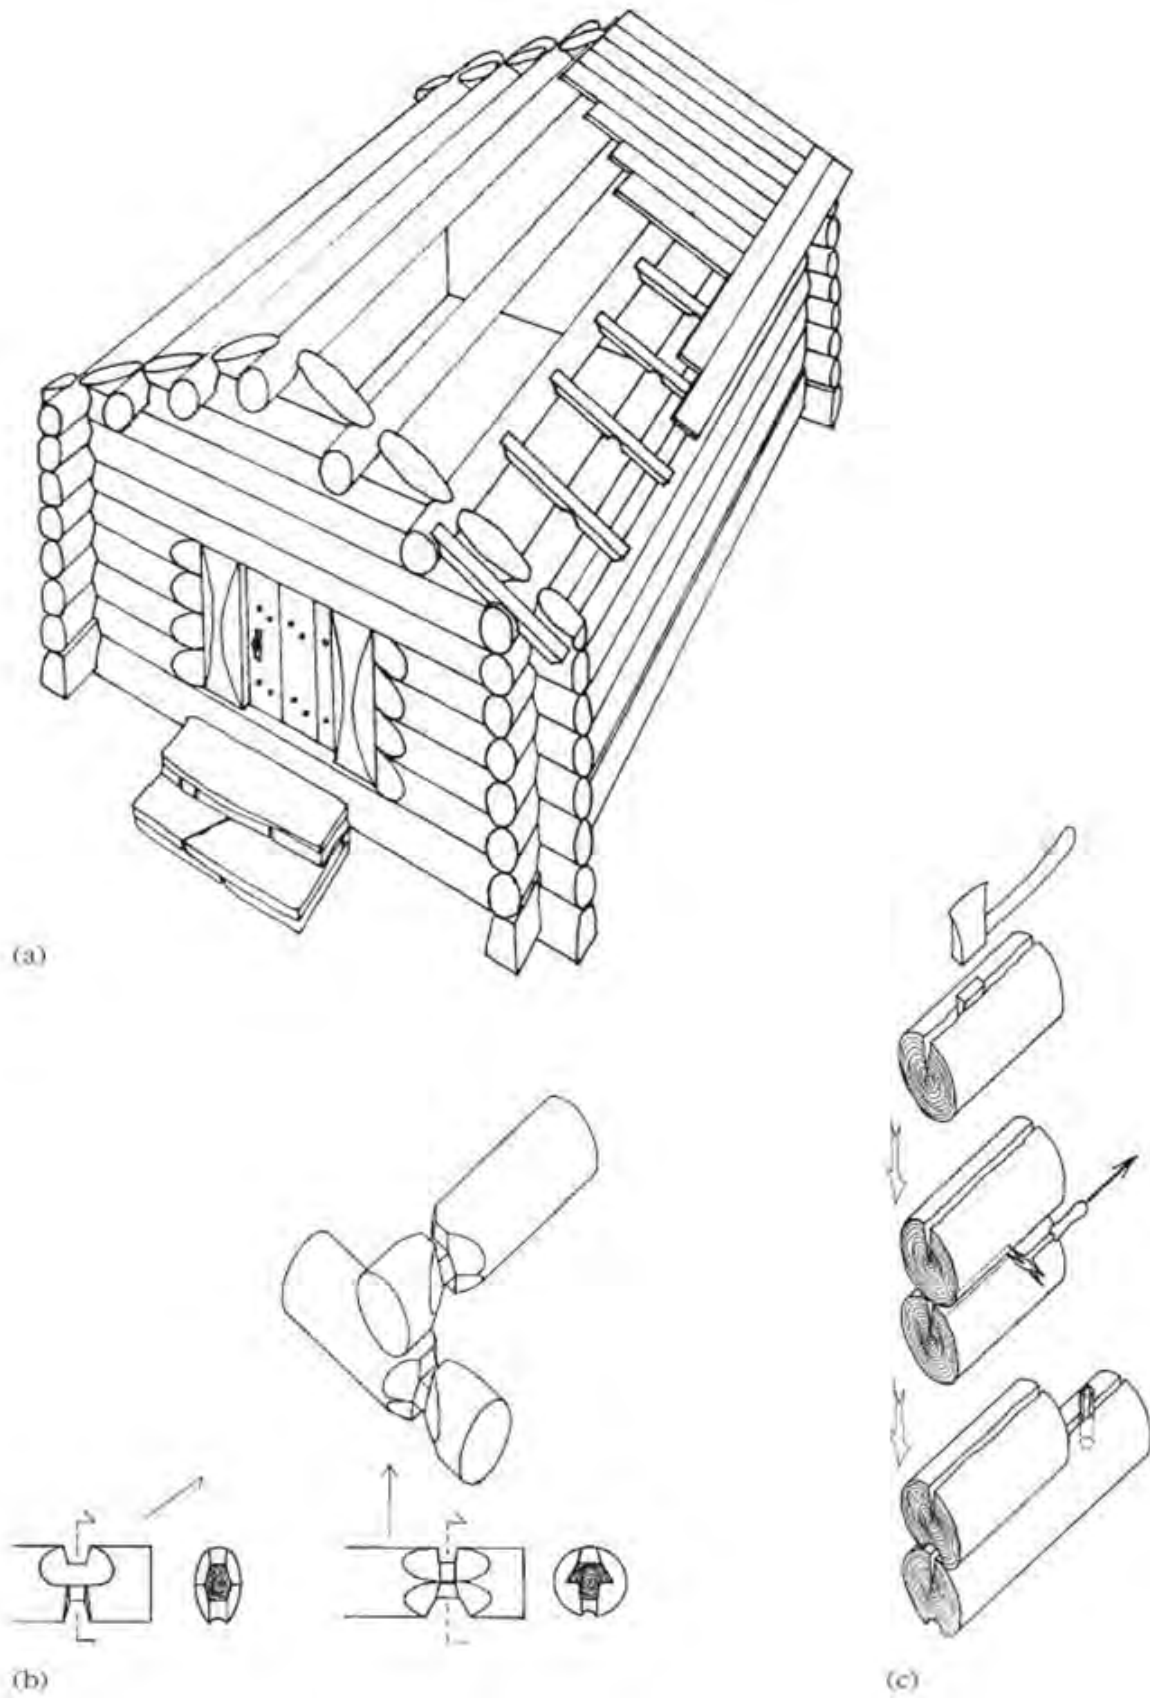
Figure 3.7 (a) Log construction, (b) Typical corner notch, (c) Conversion technique ensuring tight fit between the logs.

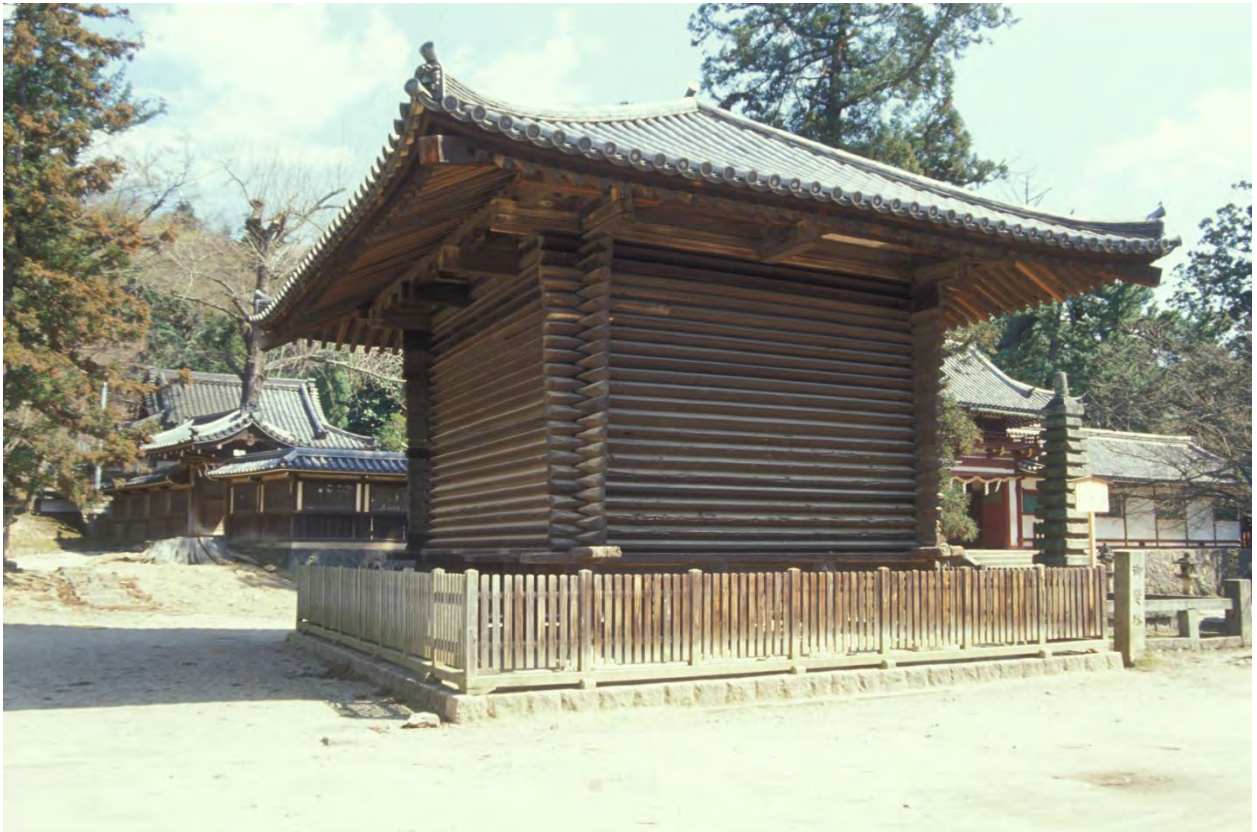
Figure 3.8 A log-structure from the Todai-ji Buddhist temple in Nara, Japan (Todai-ji Hokkedo Kyoko) This is the sutra repository, a storehouse for keeping the sacred books of Buddhism, built in the eighth century

Figure 8.9 Detail from a log-structure from the Todai-ji temple in Nara, Japan, built in the eighth century (see Figure 3.8). The cross-section of the original eighth century logs has been greatly reduced due to weathering. The new log, clearly distinguishable, was added during repair completed in 1964.

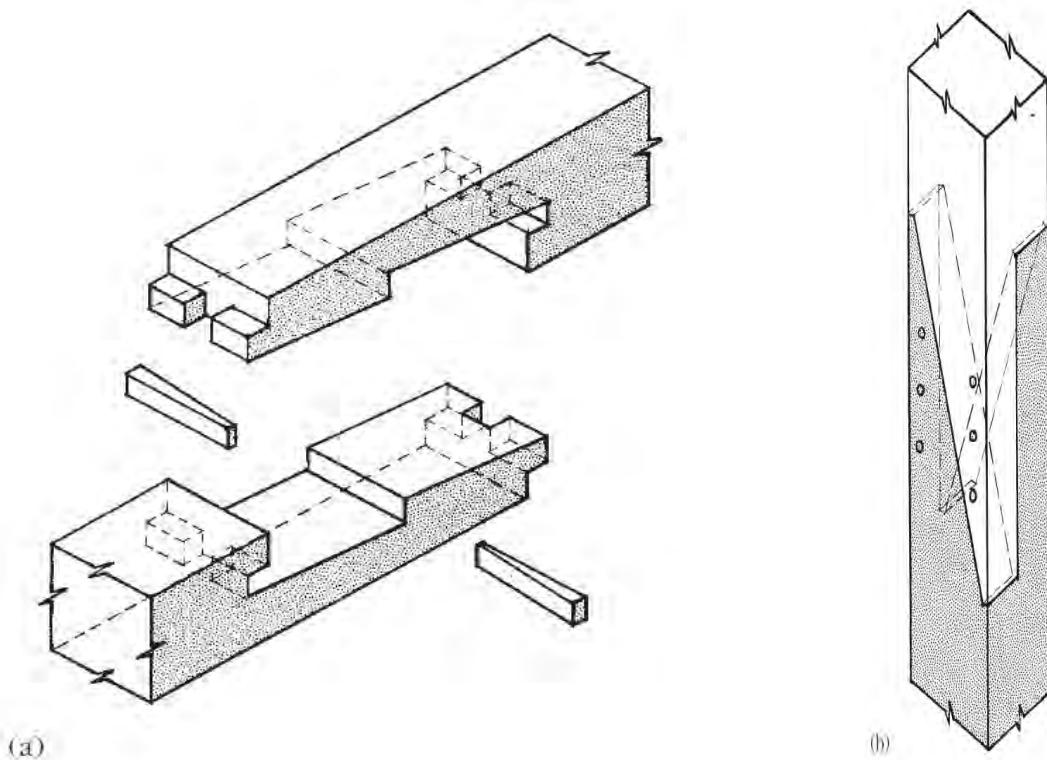
Figure 3.11 (a) Complex lengthening joint. (b) Scissor scarf joint for use on load-bearing members.

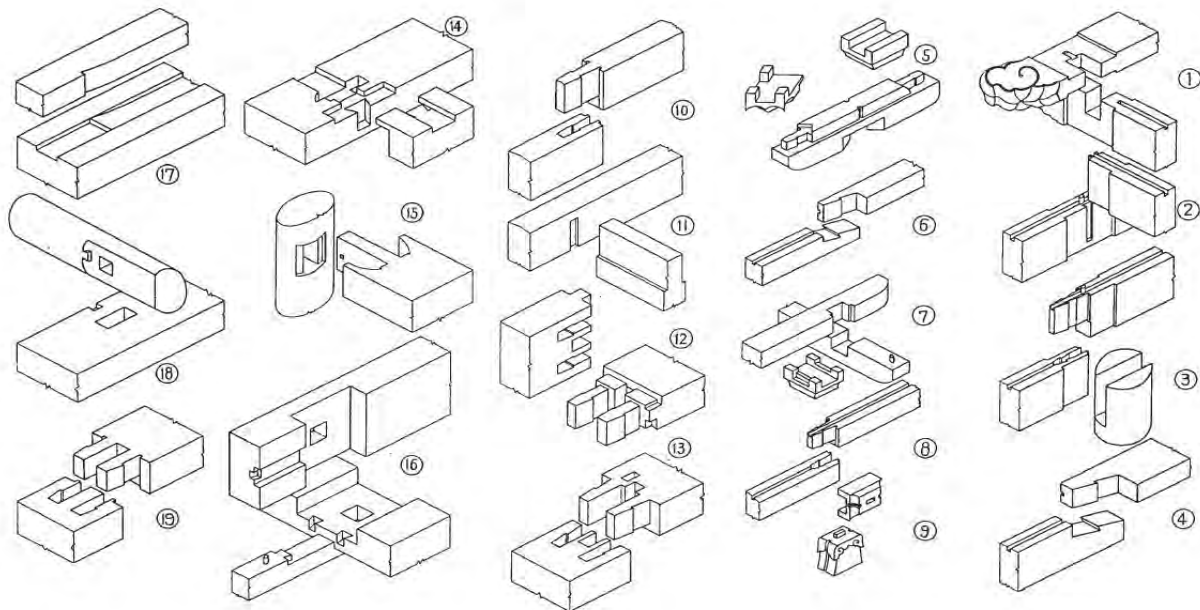
Figure 3.12 Joints used in the Nyoirindo hall of the Daigo-ji Buddhist temple in Kyoto, Japan. The hall was built in 1606. (Drawing from *Juyo bunkazai Daigoji nyoirindo shuri koji hokokusho*. Kyoto Prefecture Board of Education. 1964.)

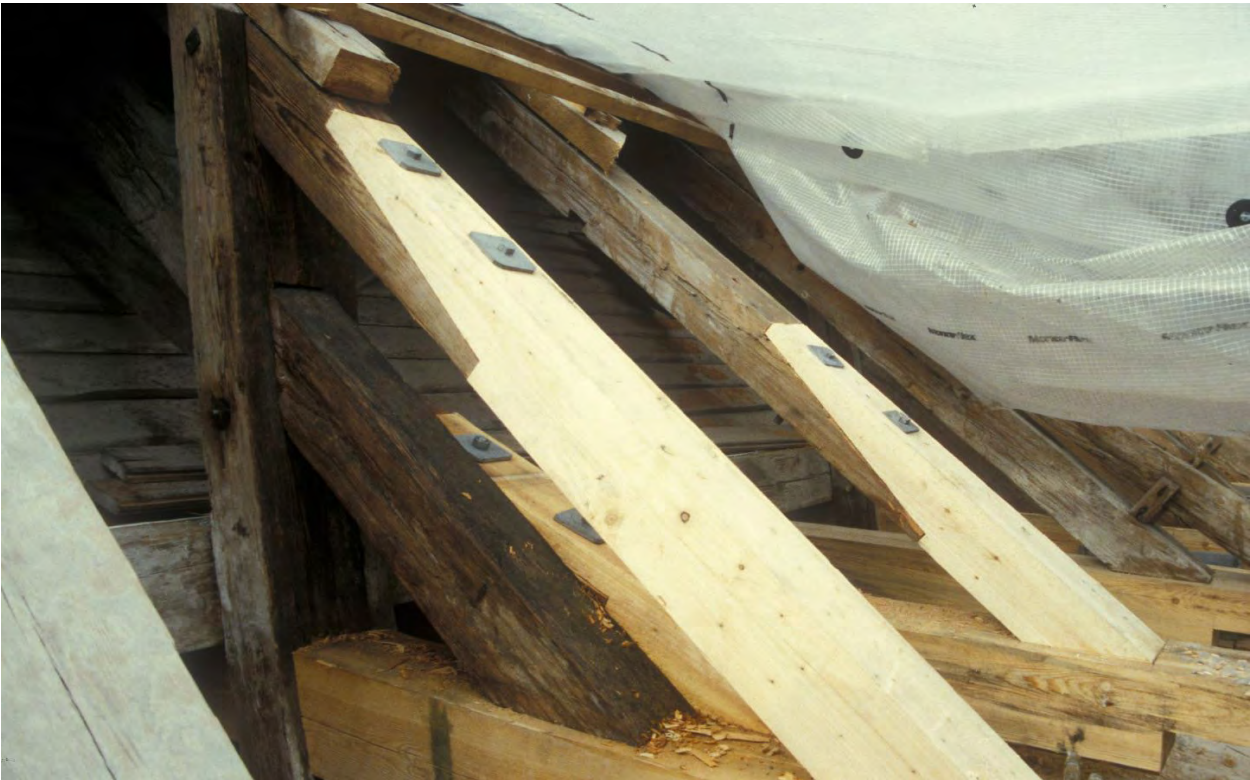
Figure 4.1 Hørsholm church outside Copenhagen, Denmark. Repair of rafters 1997. New and old timber is jointed and the joint reinforced with steel bolts and toothed-plate connectors.

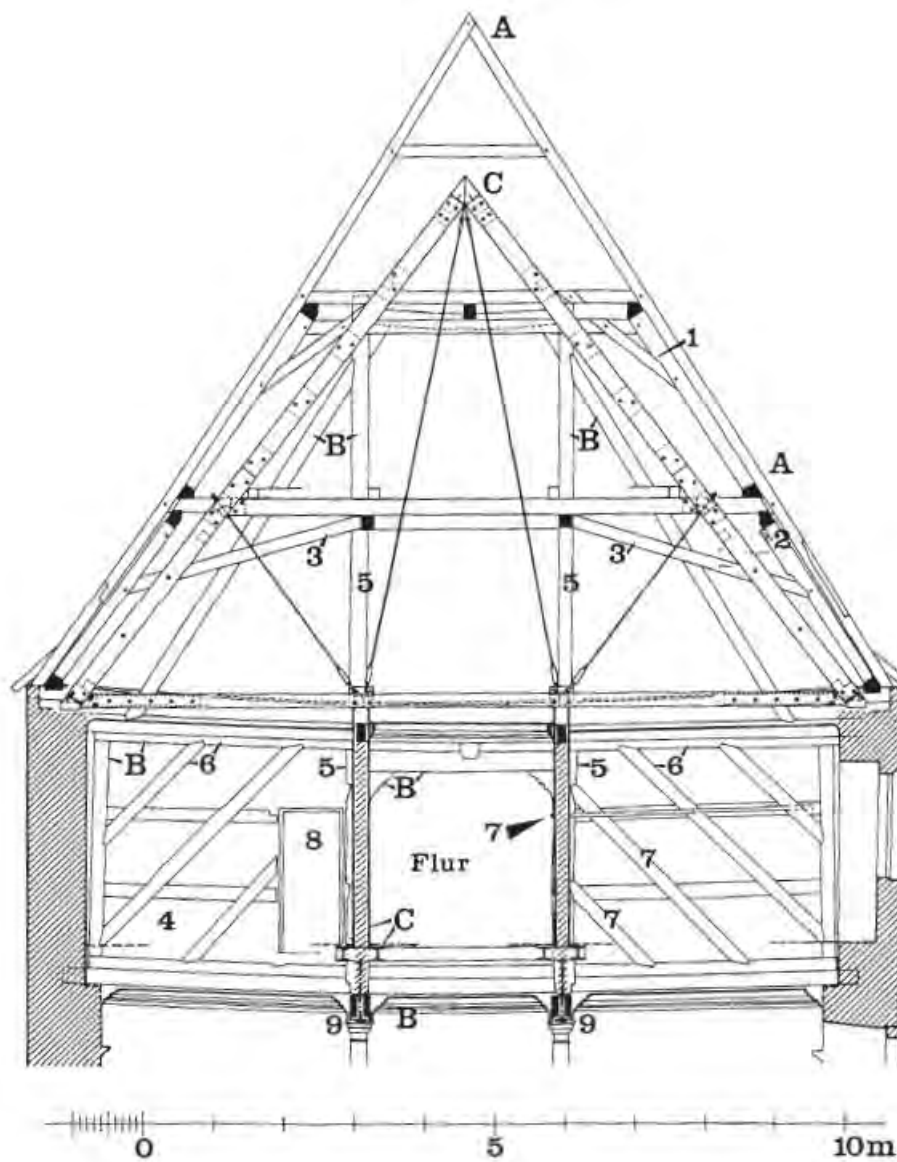
Figure 4.2 Grumbach castle, Rimpf, near Würzburg, Bavaria. The castle's medieval south wing was rebuilt in the early seventeenth century. During the rebuilding, the late Gothic and original roof trusses were kept largely intact, although today some parts are missing. The seventeenth century rebuilding included strengthening the roof with an additional timber structure. At the beginning of the 1980s it had become necessary to strengthen the roof structure once again.

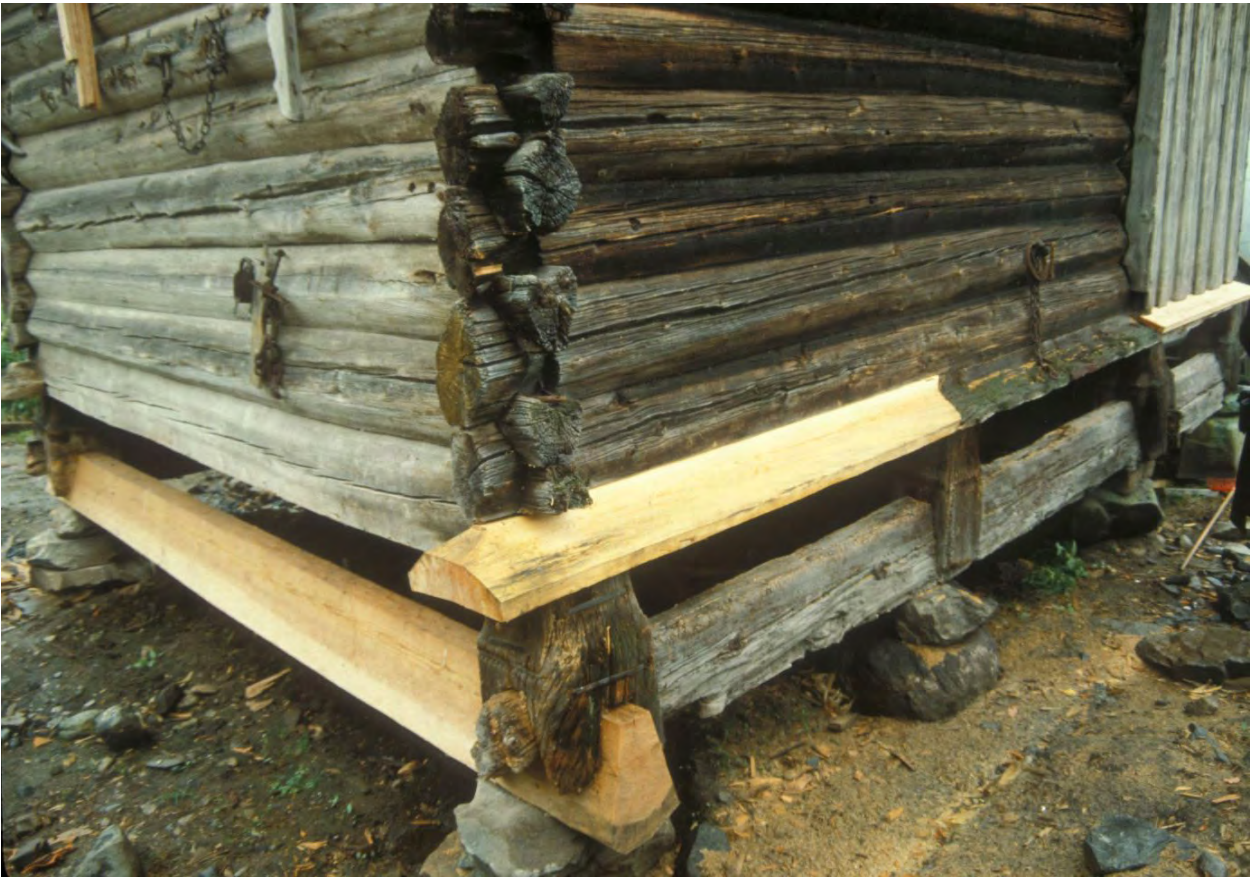
Figure 4.3 Repair in timber by copying old members. Tokke, Norway.

and the upper log, the walls of medieval log buildings have generally not been repaired since they were built. Dismantling has no tradition as part of the repair process here. When the sill beam needed to be replaced, the carpenters jacked up the building. Today, when it is necessary to repair a log in the middle of the wall, small hydraulic jacks

are used to force two logs apart in order to give the carpenter access to repair the decayed part, or to replace the log. This method works due to the flexibility of the structure and the nature of the corner joints which give a log building its rigidity. However, the dismantling of log buildings is well-known in Norway throughout history, because farm buildings were often moved from one site to another; in such cases dismantling was a convenient method. Farmers' daughters were often given one or more of the farm buildings as a dowry, in order to enable them to set up their own farms. The buildings would be dismantled and re-erected on a new site.

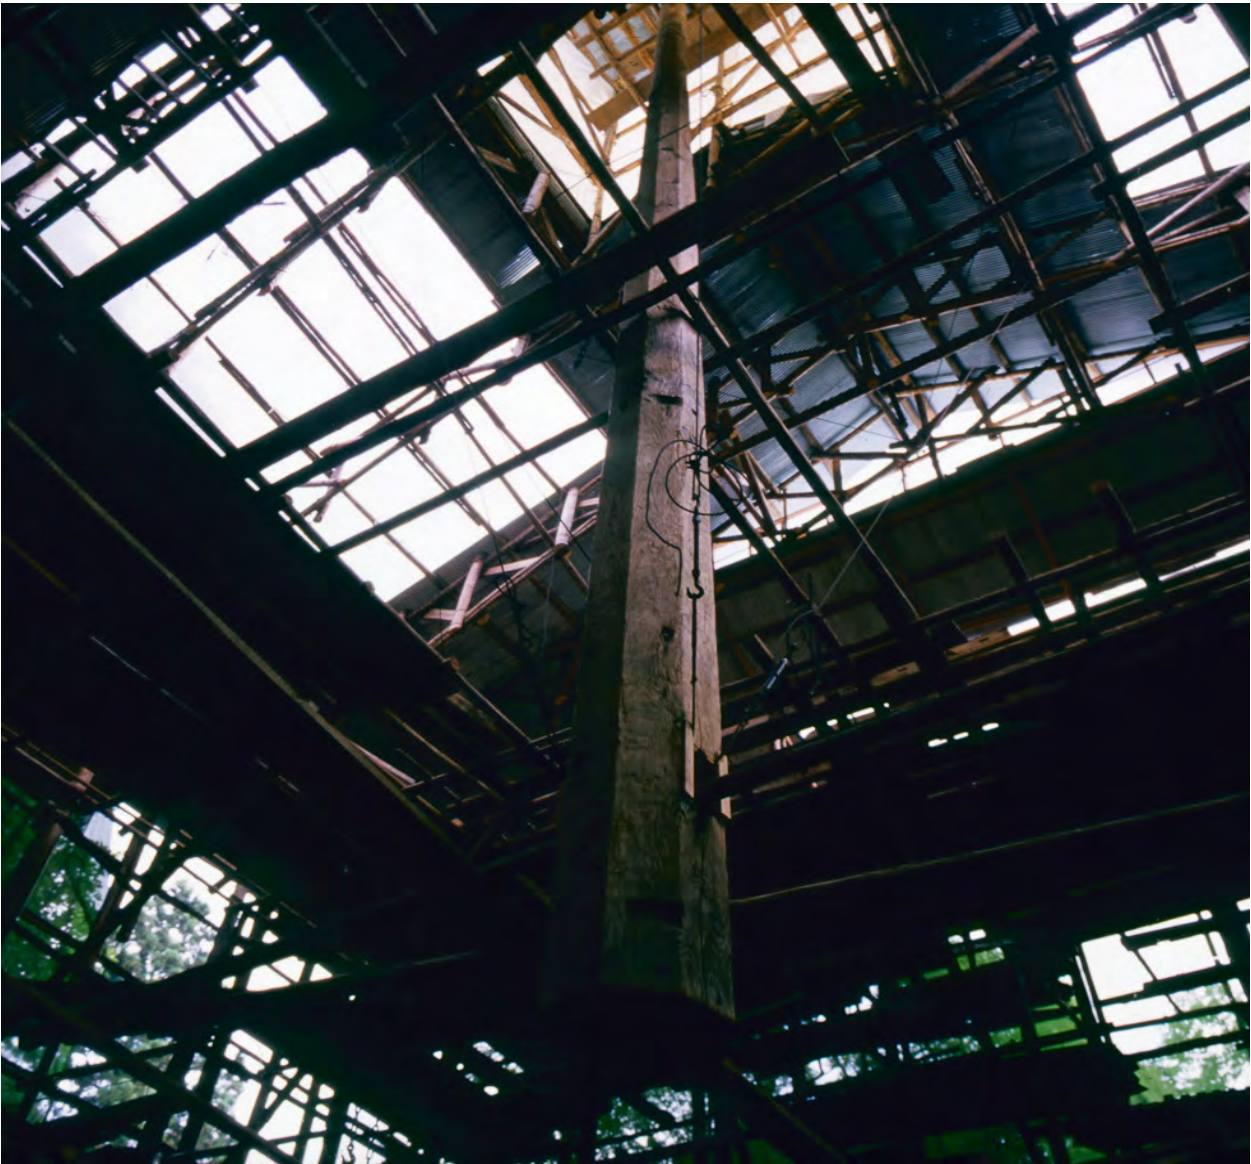
Figure 4.5 The central pillar of the three-storied Oyama-dera pagoda during preservation work in 1989. All members of the pagoda have been dismantled except the central pillar which is suspended from the scaffolding.

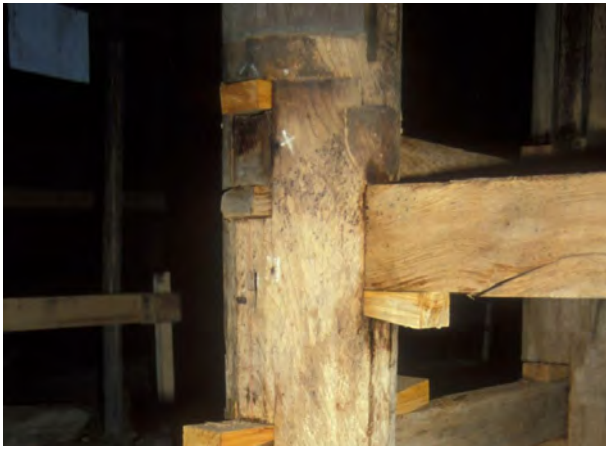
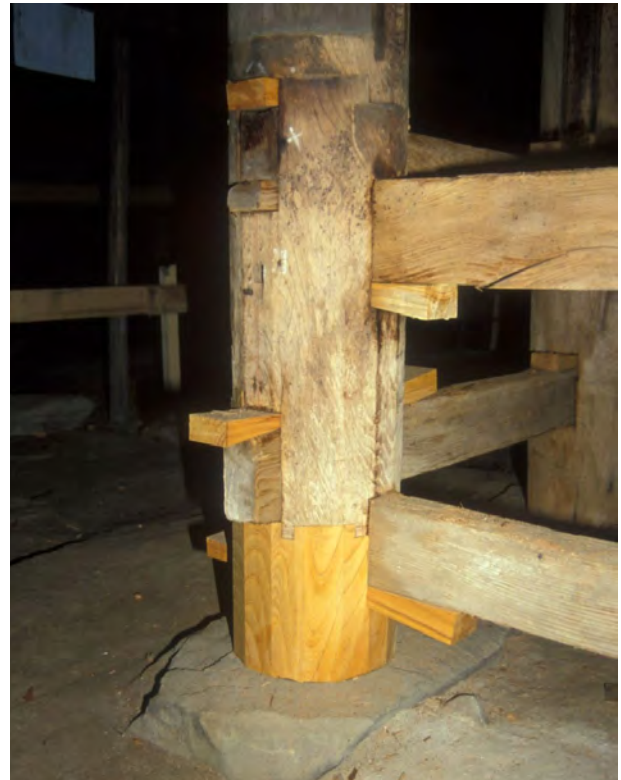
Figure 4.6 (a) Oyama-dera three-storied pagoda. New bracket arms were inserted during the repair in 1989. (b) Oyama-dera three-storied pagoda. Repair of the lower part of one of the four main pillars by splicing in new timber.

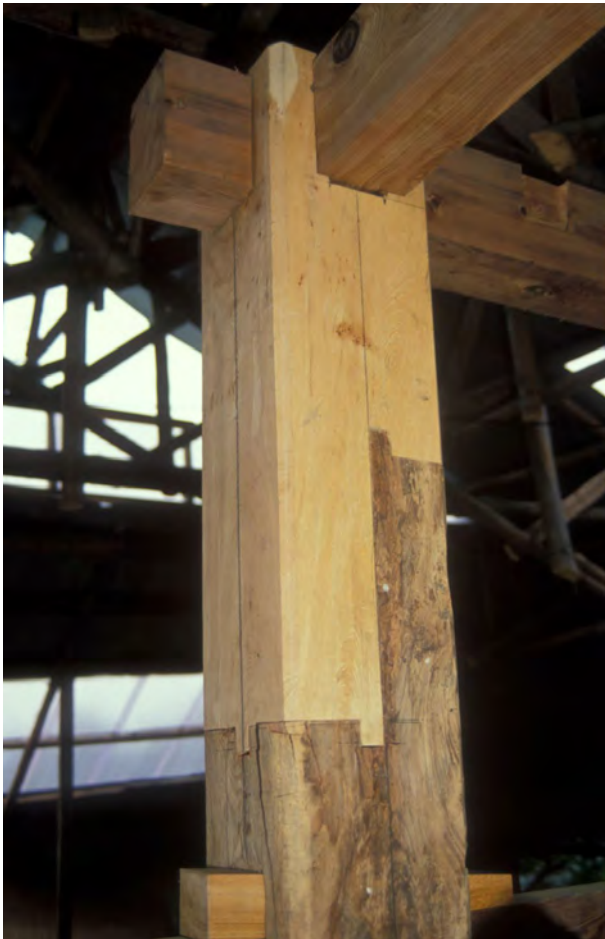
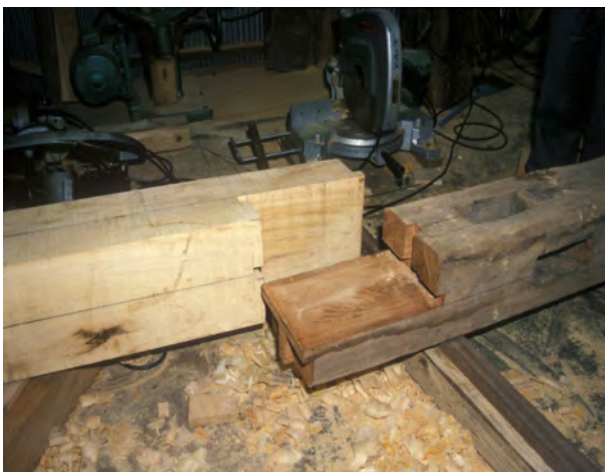
Figure 4.7 (a) Oyama-dera three-storied pagoda (top part of the pagoda). Repair by jointing new, well-seasoned timber to the existing member. (b) The members before re-assembly. The joint used in this case is an edge-halved scarf, with butts lipped and bridled.

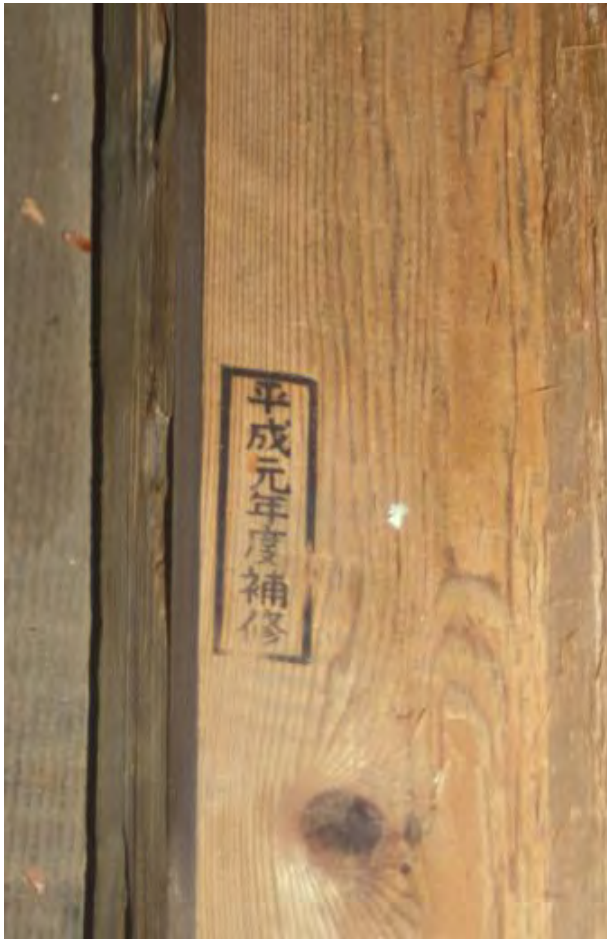
Figure 4.8 New members or parts of members should have the date of the repair inscribed on them so that they can be identified later. Here is an example from Japan where the date of the repair is burnt into the wood. The characters mean Heisei gannen go hoshu, that is: this piece of timber was put into the structure in 1989, the first year of the Heisei era.

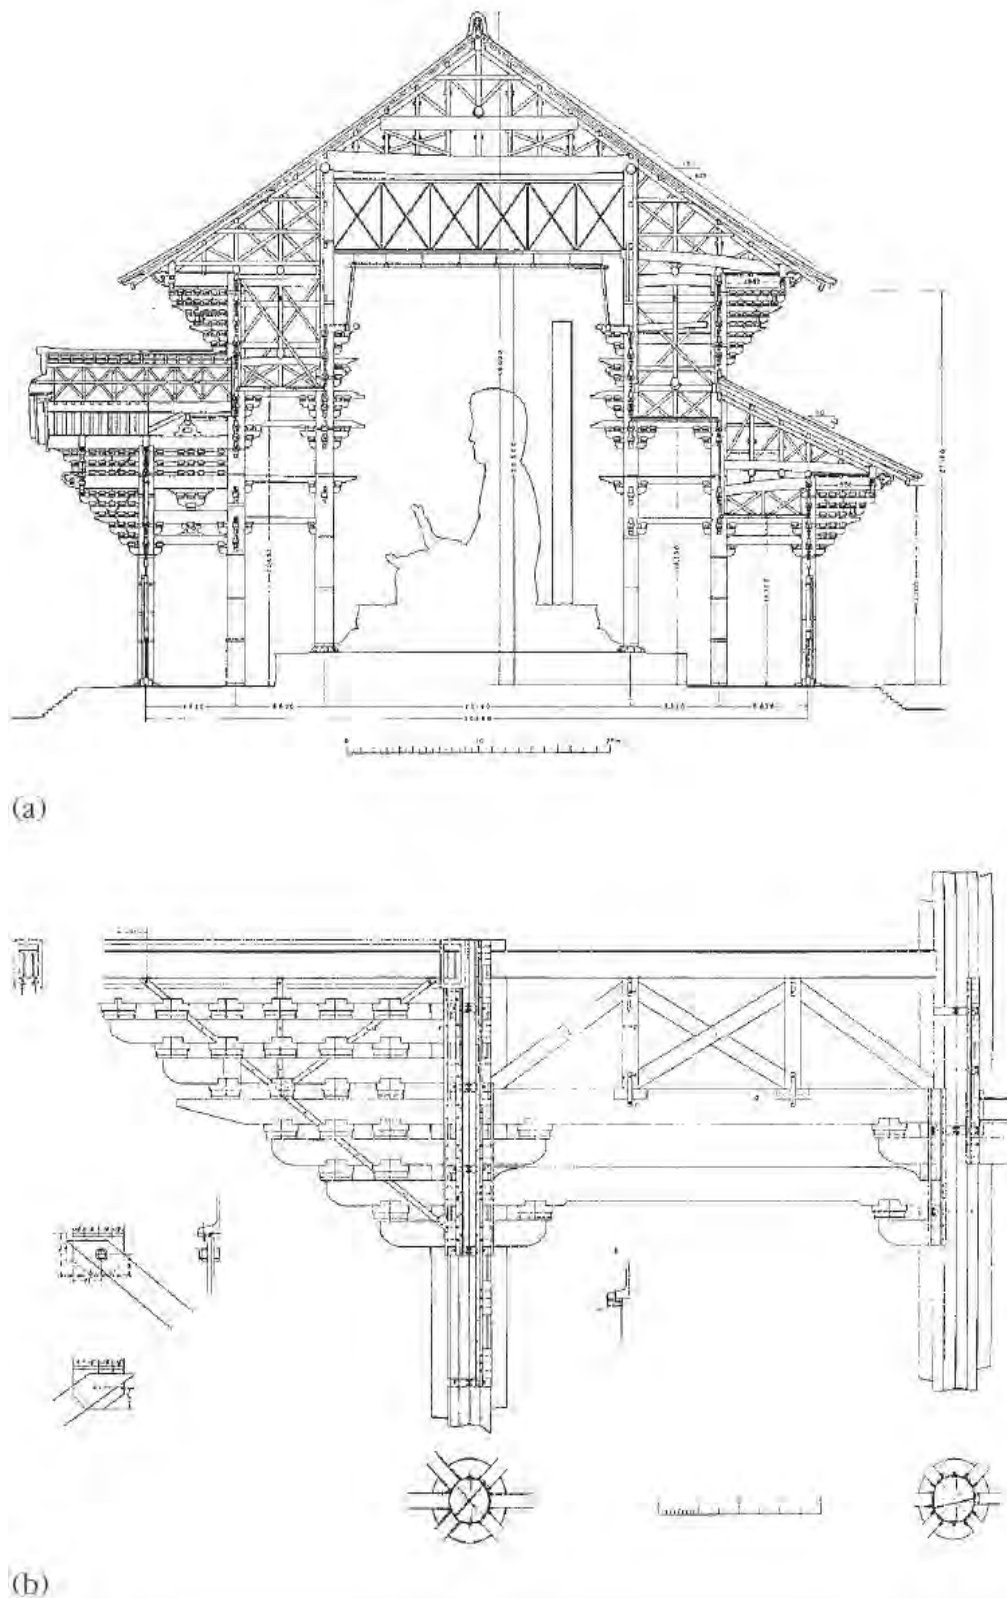
Figure 4.10 (a) The Great Buddha Hall (Daibutsuden) of the Todai-ji temple, Nara, Japan. Section after the restoration of 1903-1913 when steel girders were added to reinforce the structure. (b) Steel reinforcement of the timber frame and reinforcement of a bracket complex with flat steel bars done during the restoration of the hall 1903-1913. (Drawing from *Kokuho Todaiji kondo (Daibutsuden) shuri koji hokokusho*. Nara Prefecture Board of Education. 1980.)
