Conservation of Historic Timber Structures

An ecological approach

Knut Einar Larsen & Nils Marstein

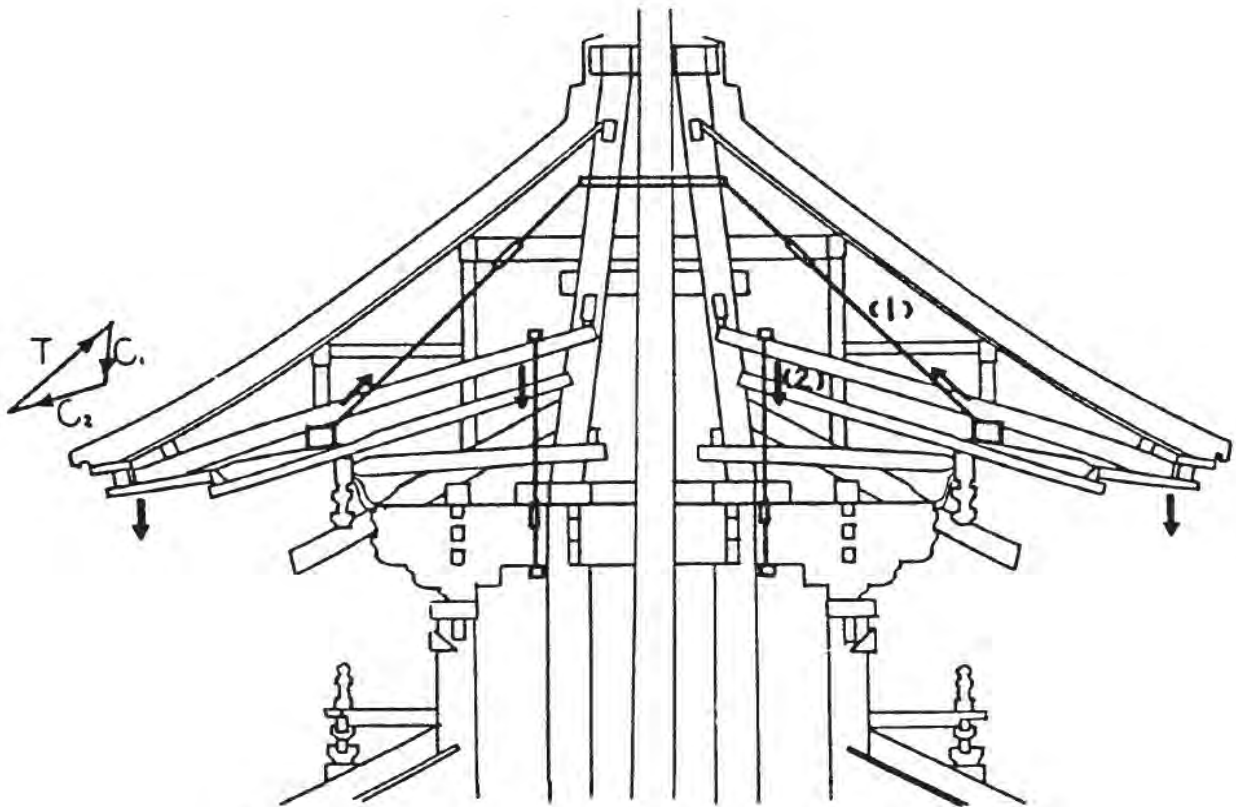
Figure 4.11 The three-storied pagoda of the Kiyomizu-dera Buddhist temple in Kyoto, Japan, built in the early seventeenth century. Cross-section of the upper roof. During the repair completed in 1986, turnbuckles were introduced to reinforce the roof structures carrying the load of the projecting eaves. (Drawing from *Juyo bunkazai Kiyomizudera sanju-no-to shuri koji hokokusho*. Kyoto Prefecture Board of Education. 1986.)

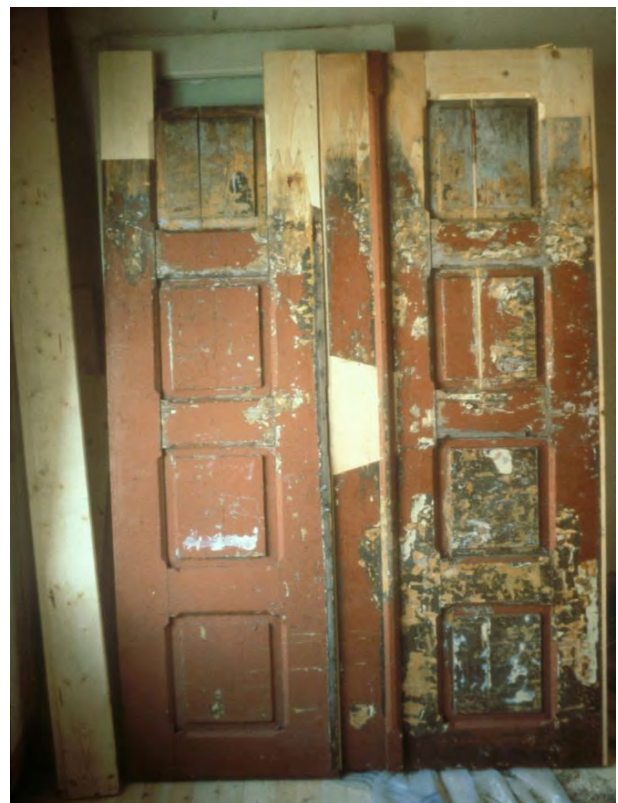
Figure 4.12 Pieced-in repair of a door. Mosjøen, Norway.

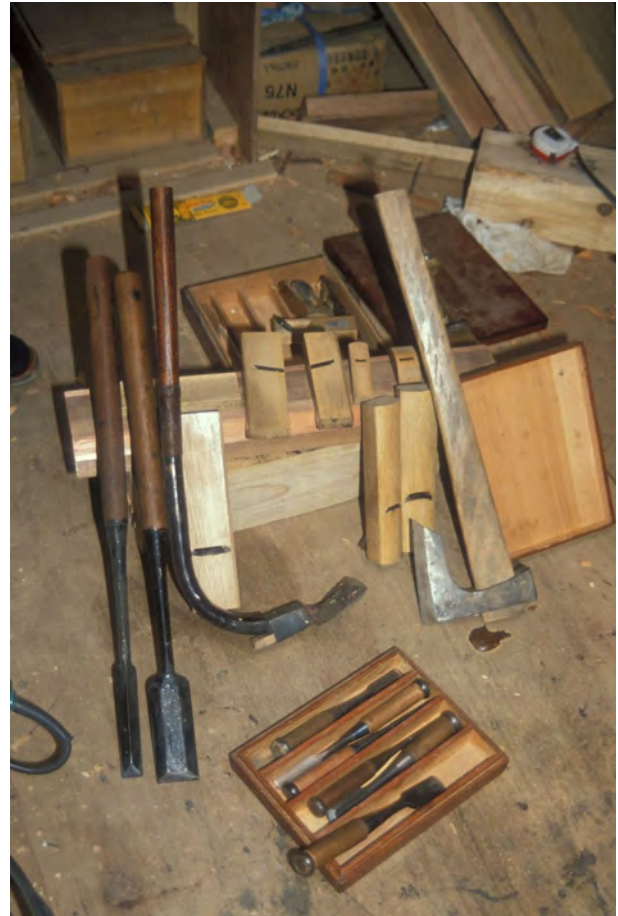
Figure 5.1 Tools used by carpenters in the repair of the three-storied Oyama-dera pagoda, Japan in 1989: adze and axe; two kinds of chisels - used by pushing (*left*), or by striking (*tool box in centre*); planes - *left*, a common plane; *centre*, rebate planes; *right*, molding planes.

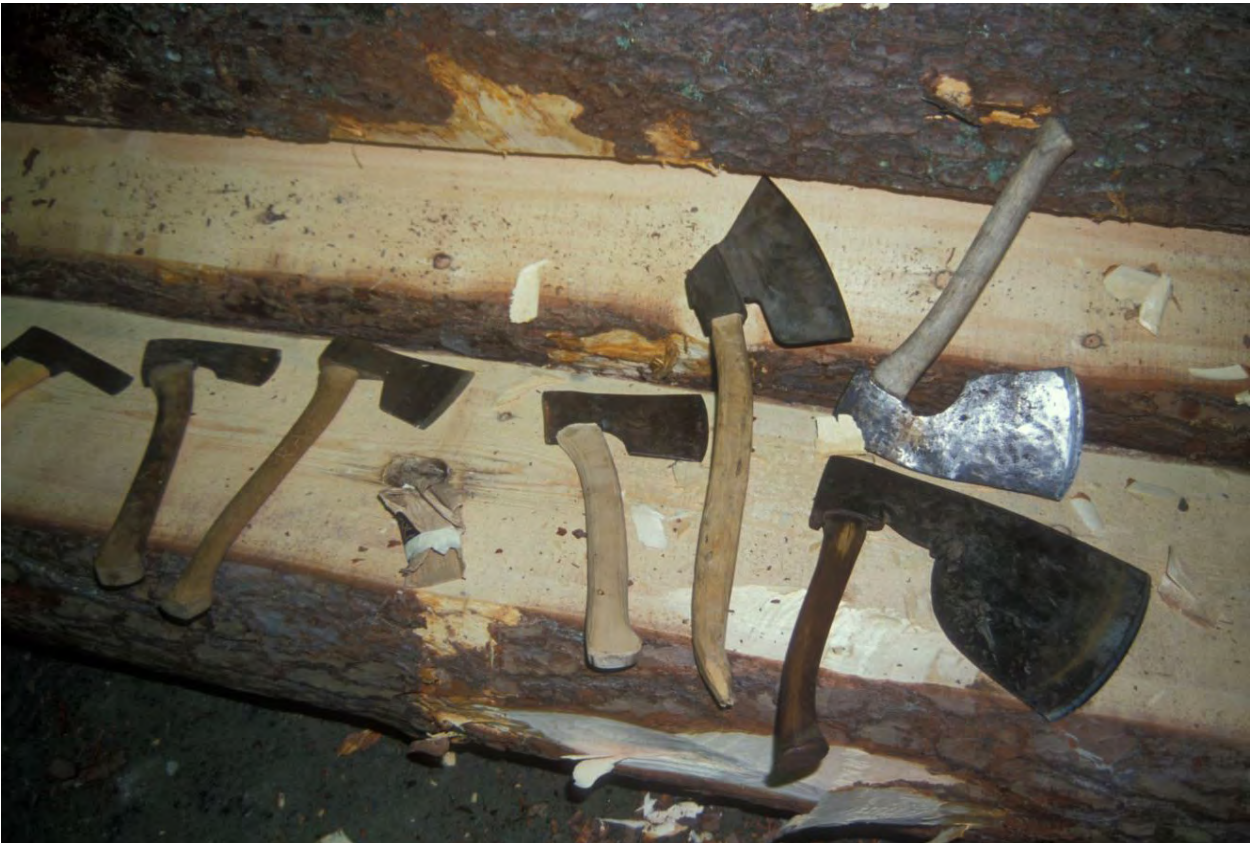
Figure 5.2 Axes used by Norwegian carpenters in the repair programme for medieval timber structures 1991-1996.

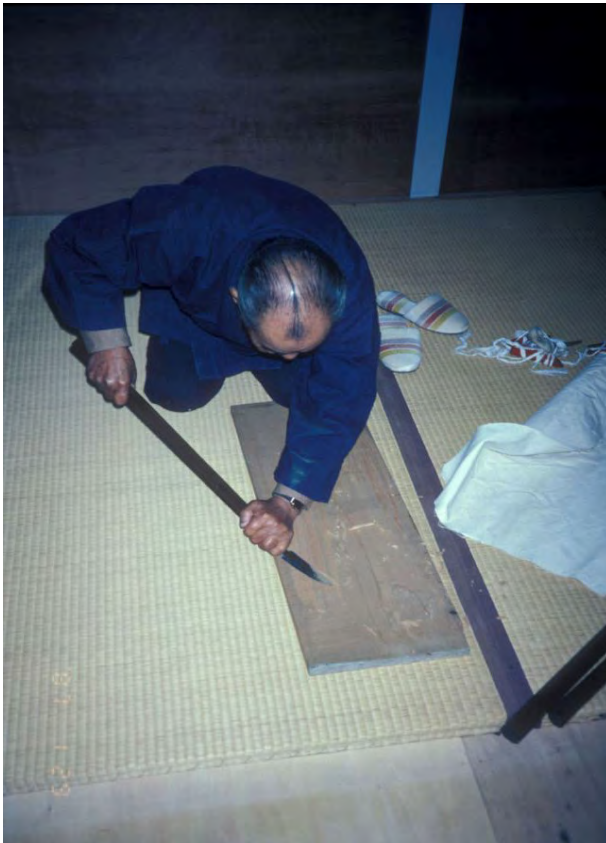
Figure 5.3 Tsunekazu Nishioka planing with the spear-shaped plane (*yari-ganna*). The Yakushi-ji Buddhist temple in Nara, Japan, 1987.

Asano and Nishioka carefully studied both the surface of the timbers, and old documents, to decide what kinds of tools the carpenters had used in the seventh and eighth centuries, and which postures the carpenters assumed when handling the tools while dressing the timber. Their studies prompted a revival of historic tools which were no longer in use, particularly the spear-shaped plane (*yari-ganna*). Their investigations showed that in the case of pillars, the timber had first been hewn with an adze, and then the surface had been finished with the spear-shaped plane. The *yari-ganna* leaves a quite distinct surface pattern, resembling a bamboo leaf. According to Nishioka, a wooden surface finished with a *yari-ganna* stays smoother for a longer period

than surfaces finished with ordinary planes. The cut is so clean along the cell walls of the wood that it prevents penetration of water and makes the wood more resistant to attack by fungi (Brown 1989: 76). Thus, the seventh-century Japanese carpenters' skill with the *yari-ganna* when working with top quality Japanese cypress (*Chamaecyparis obtusa*) goes a long way towards explaining why a large percentage of original timbers can still be found in preserved buildings from the seventh and eighth centuries.

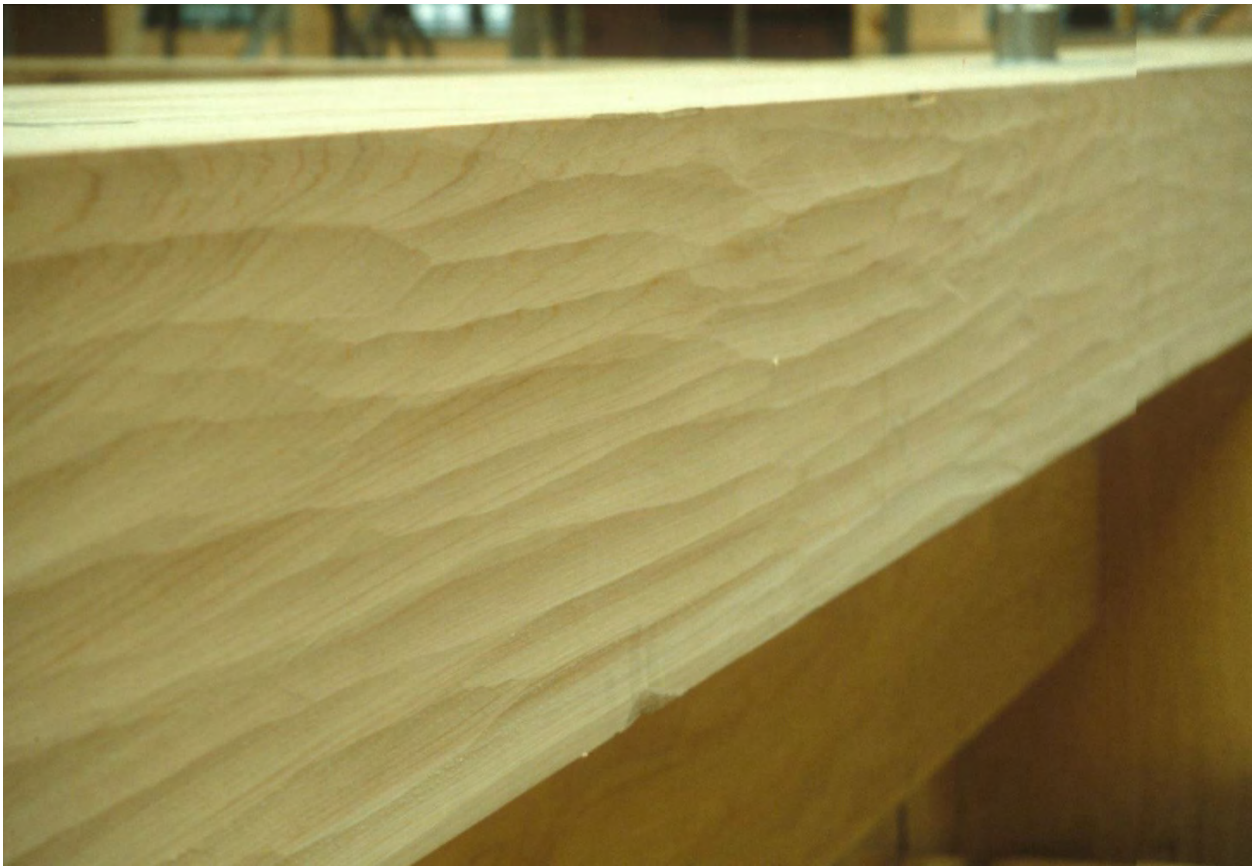
Figure 5.4 Surface of a beam of Japanese cypress (*Chamaecyparis obtusa*) prepared using the *yari-ganna*.

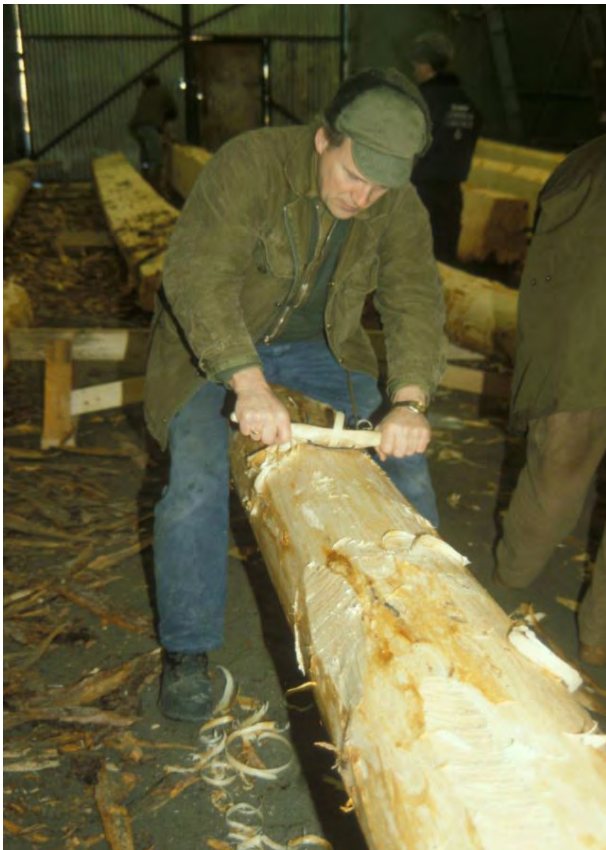
Figure 5.6 Carpenter planing a log with a spokeshave.

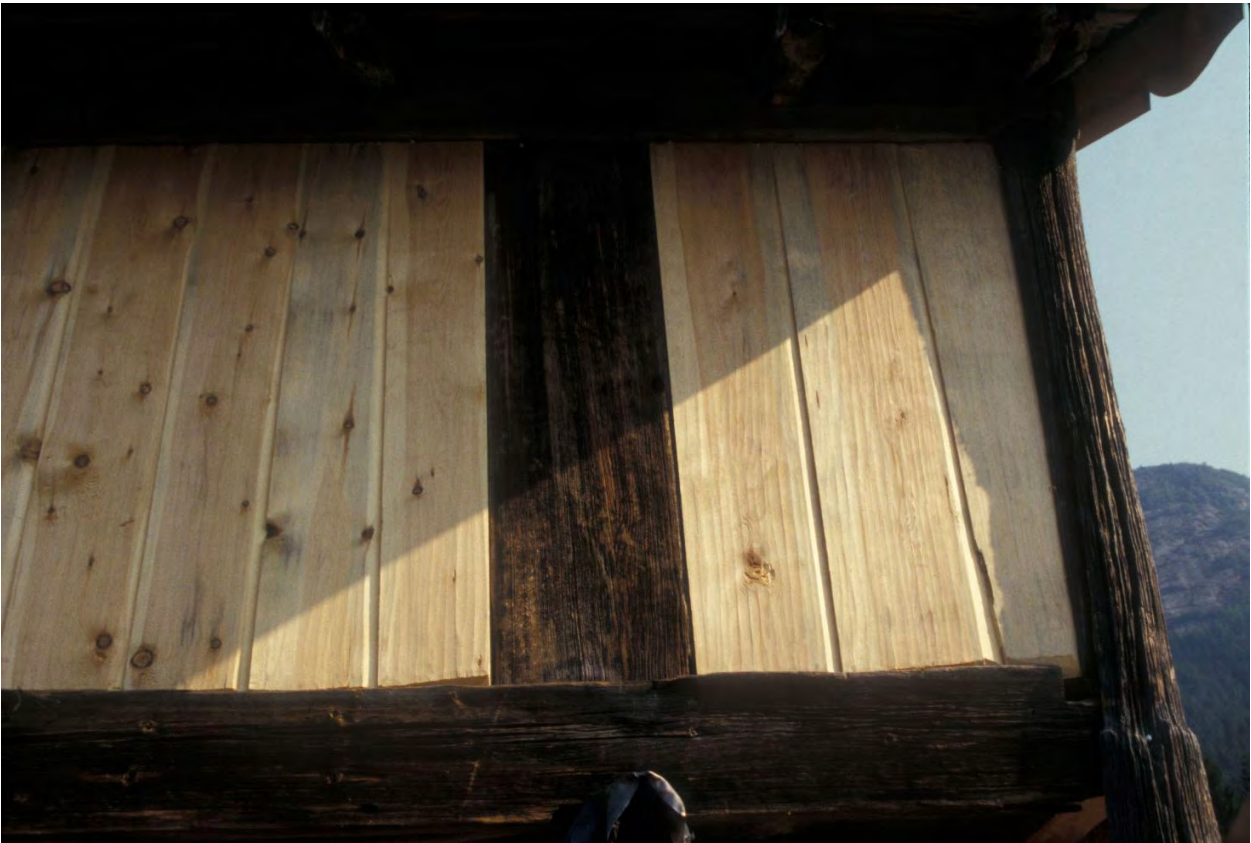
Figure 5.6 Boards inserted into the gallery wall of a Norwegian medieval timber structure during repair work. The boards have been planed using a spokeshave.

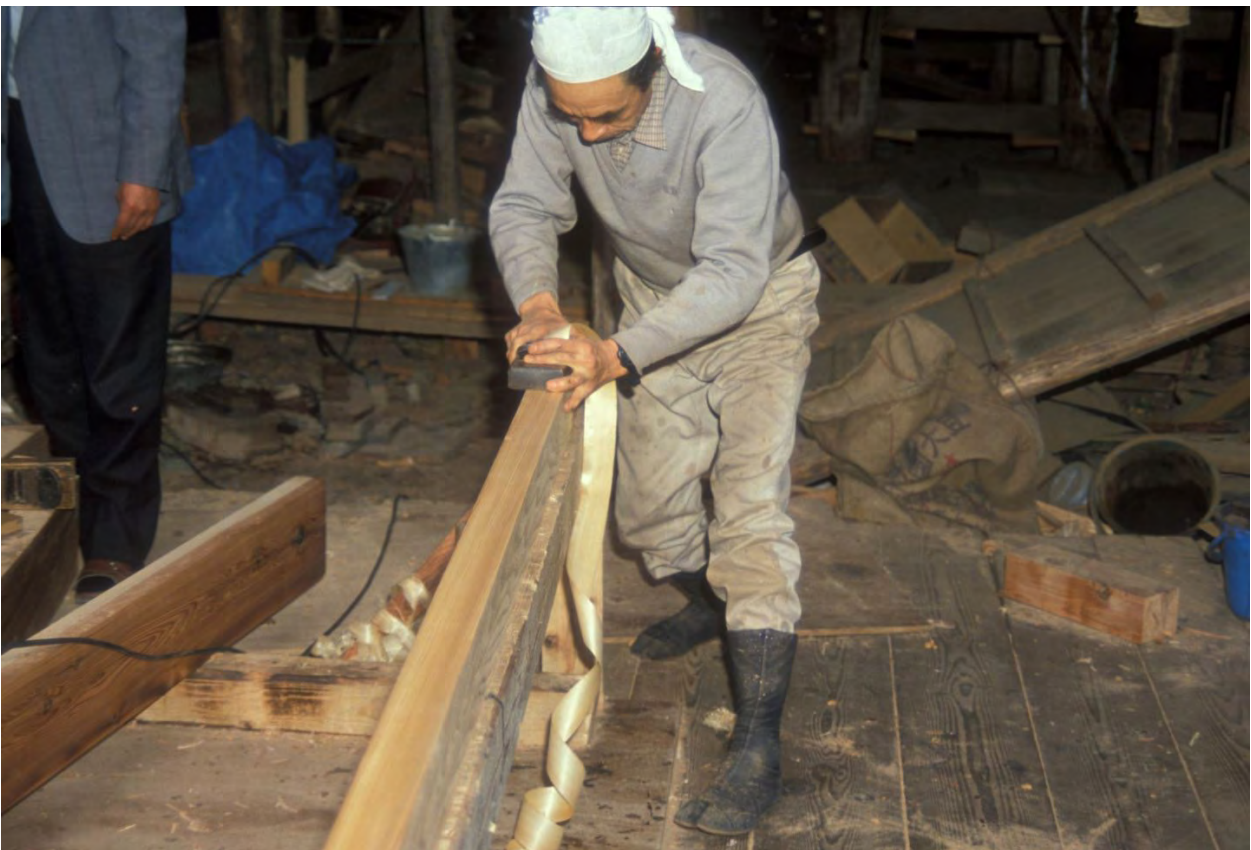
Figure 5.7 Carpenter at the repair site of the three-storied pagoda of Oyama-dera, Ibaraki, Japan in 1989. planing. The long, perfect shaving is a trademark of the excellence of Japanese carpentry work. The carpenter is pulling the plane.

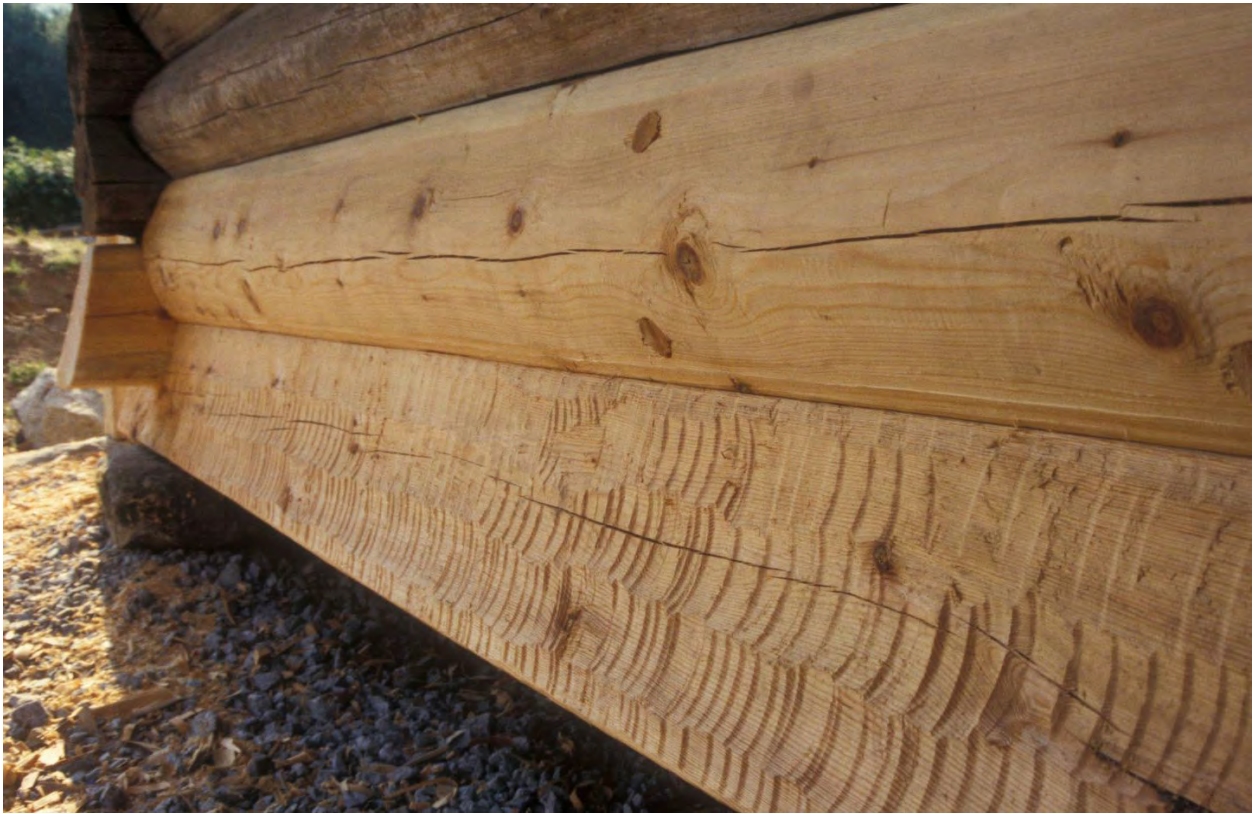
Figure 5.8 A sill beam prepared using *sprett-telgjing*.

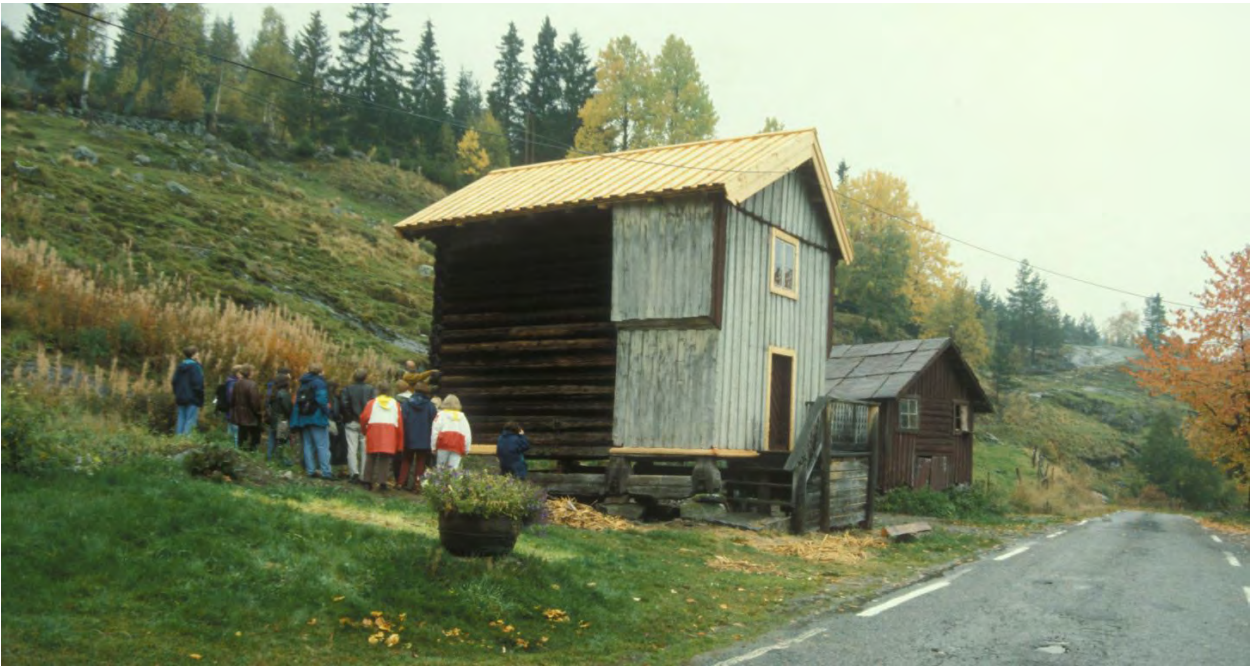
Figure 5.9 A repaired medieval timber building in Tokke, Norway. Only minor repairs have been made to the log-structure. The roof boarding has been completely renewed.

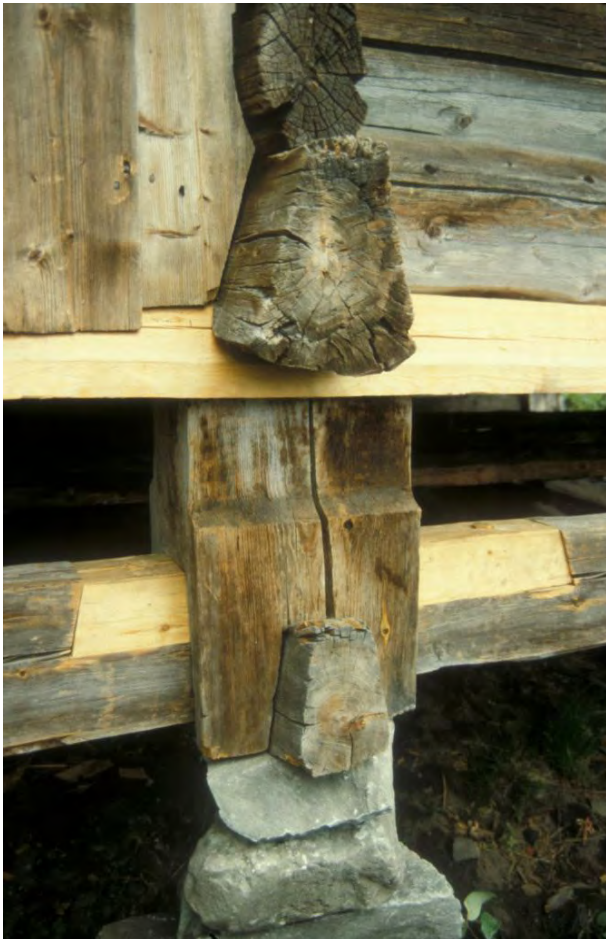
Figure 5.10 Repairing a medieval storehouse in Tokke, Norway. The structure is repaired in situ without dismantling. New, well-seasoned wood is jointed in.

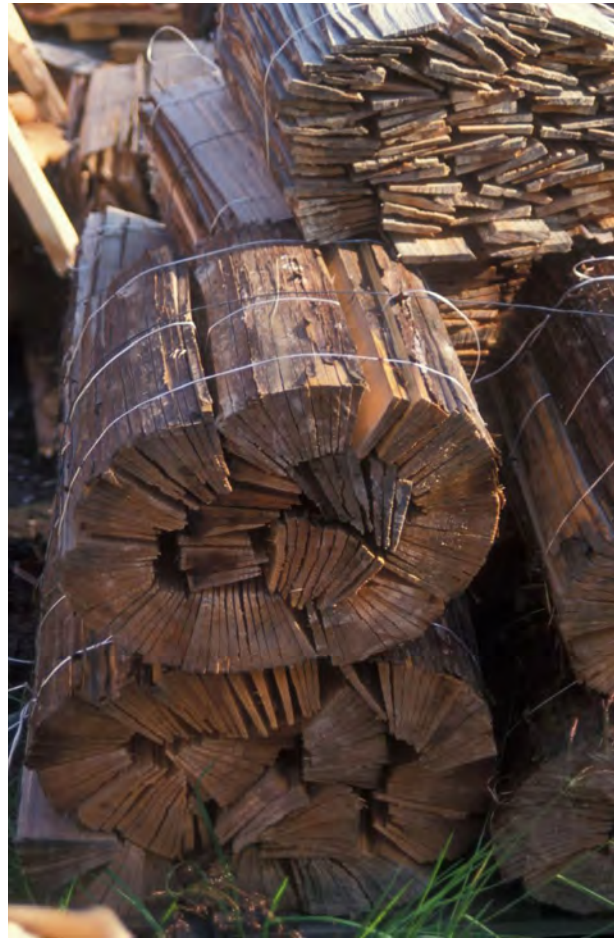
Figure 5.11 Cleaved shingles in one of the 'material banks' established as part of the programme to repair medieval timber structures in Norway 1991-1996.

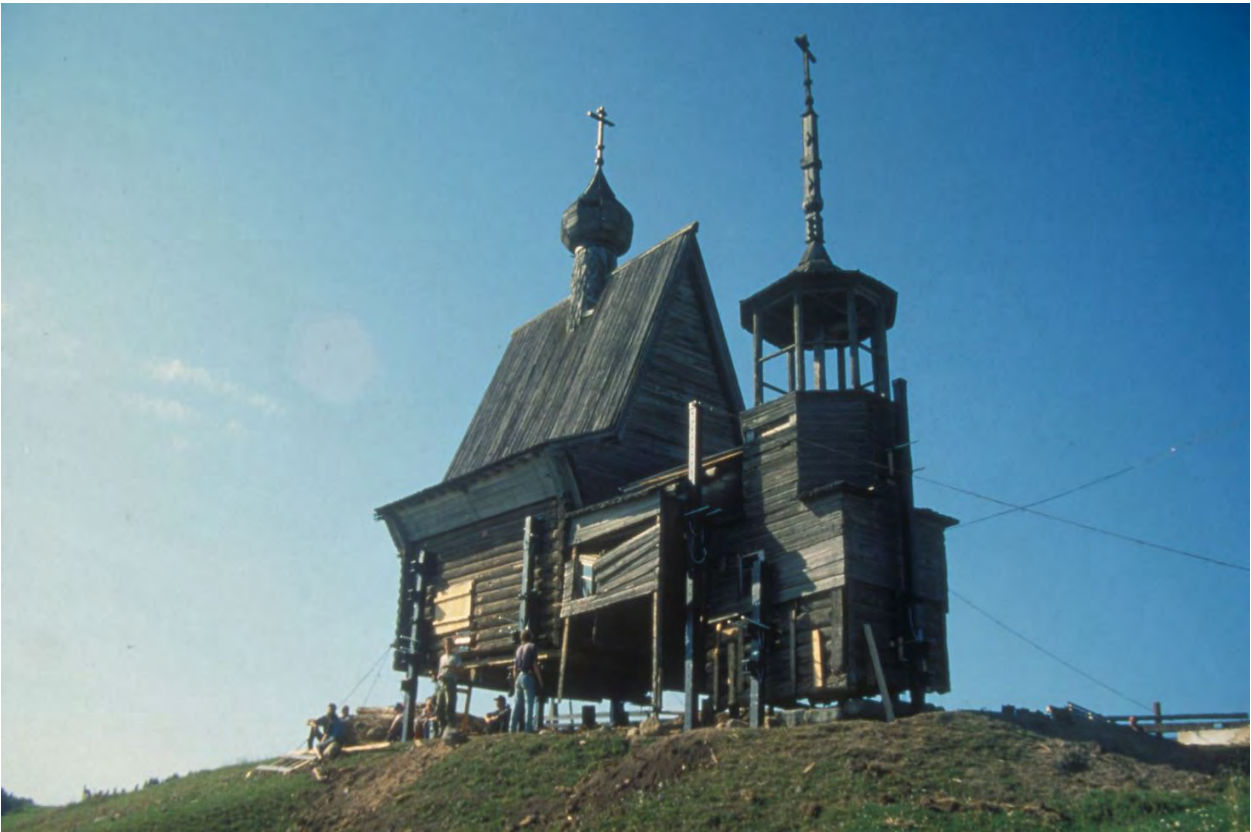
Figure 5.12 St. Nicolas Chapel, Kenozero National Park, Archangel, Russia, was restored in 1995-96 by Russian and Norwegian carpenters. The repair of the chapel is one of several joint Russian-Norwegian projects aimed at preservation of historic timber buildings through the revival of traditional techniques of craftsmanship. Hydraulic jacks and steel posts made it possible to renew rotten horizontal logs, while at the same time avoiding dismantling the chapel. (Photo by Anders Haslestad, Directorate for Cultural Heritage, Norway.)

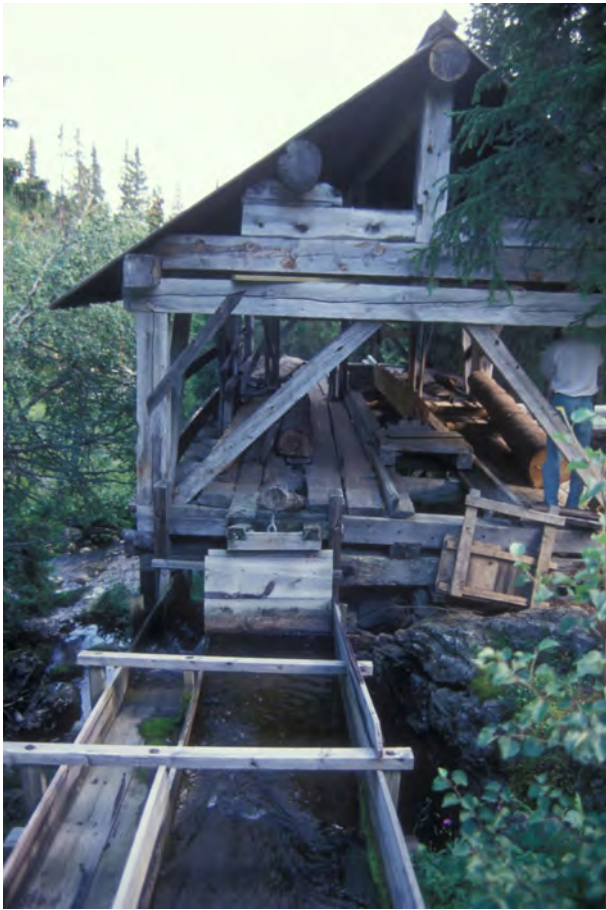
Figure 5.14 A frame saw in Rauland, Norway, which was restored together with the associated water-ways and dams as part of the Medieval Programme in Norway 1991-1996.

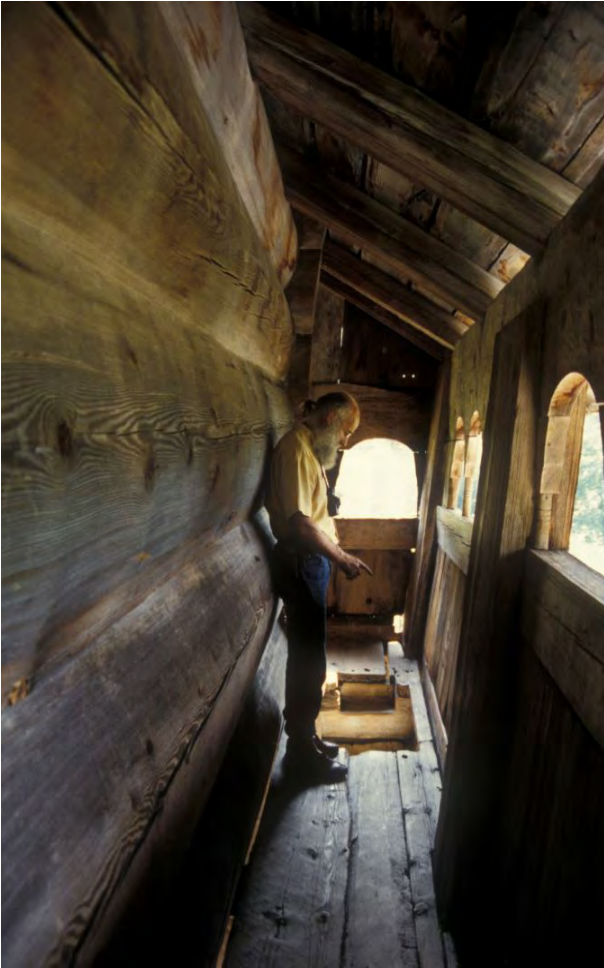
Figure 6.1 Large dimension timber from a late sixteenth century log-structure in Setesdal, Norway.

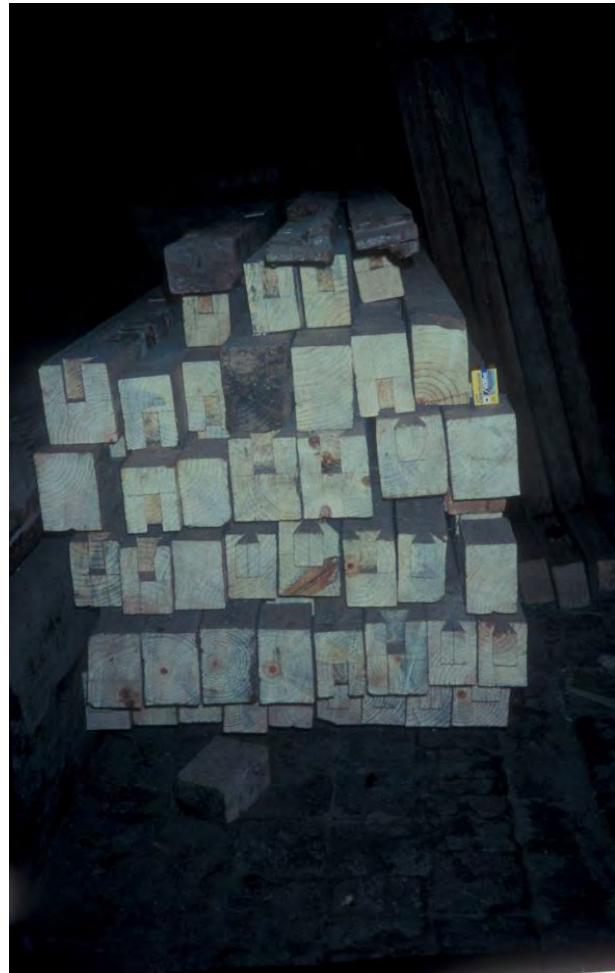
Figure 6.2 Softwood used in Nepalese preservation work. The width of the annual rings is approximately one centimetre. The amount of heartwood was almost negligible.

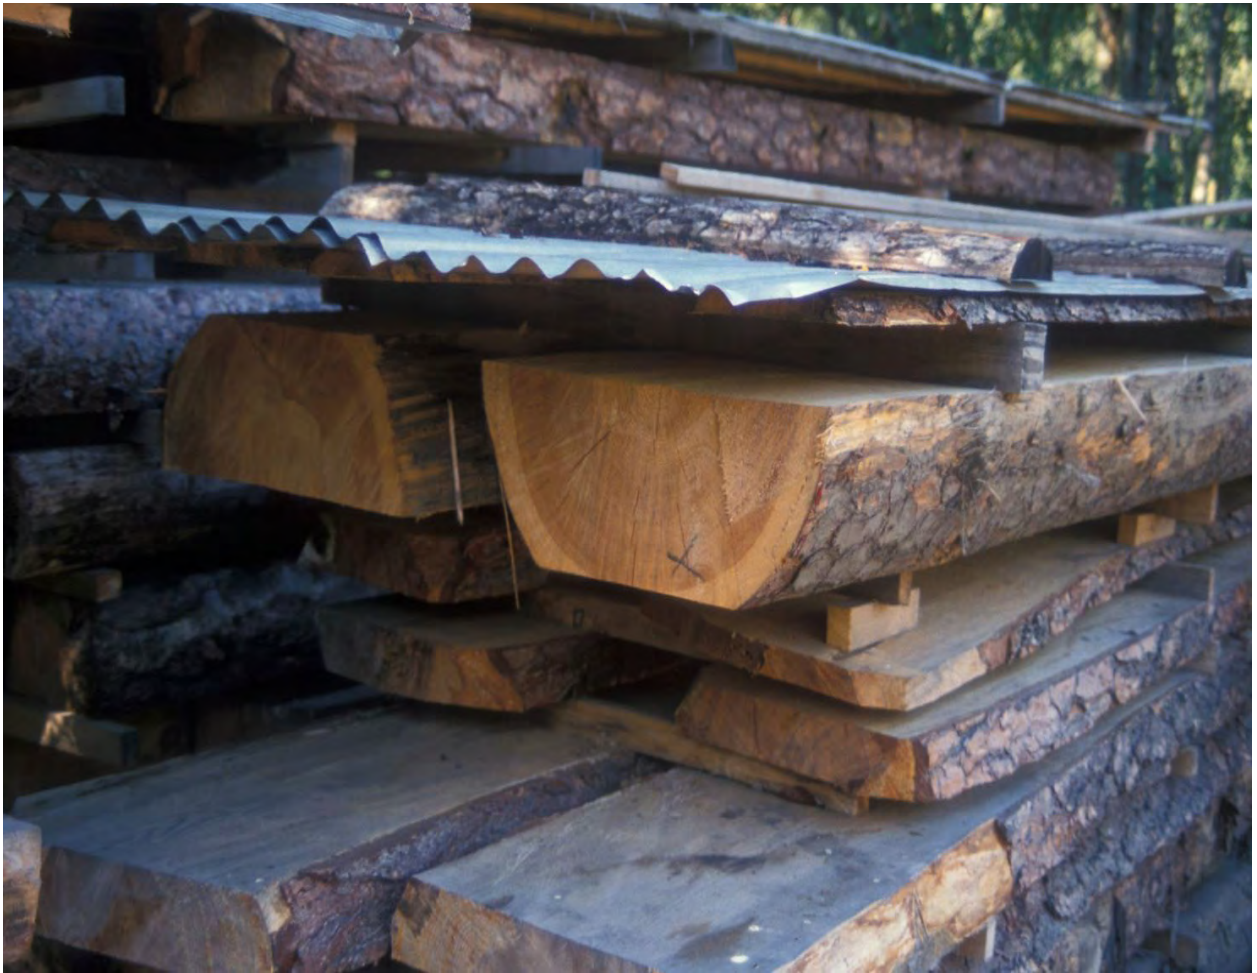
Figure 6.3 Pine with large section of heartwood in one of the Norwegian “material banks” set up during the Medieval Programme in Norway 1991-1996.

called ‘material banks’, for traditional building materials in various regions throughout the country. A major asset in the banks is old-growth pine (*Pinus sylvestris*), carefully selected in co-operation with local forest owners, and matching the quality of the timber used in the original construction work. There is a growing interest among forest owners to keep similar reserves in the future.

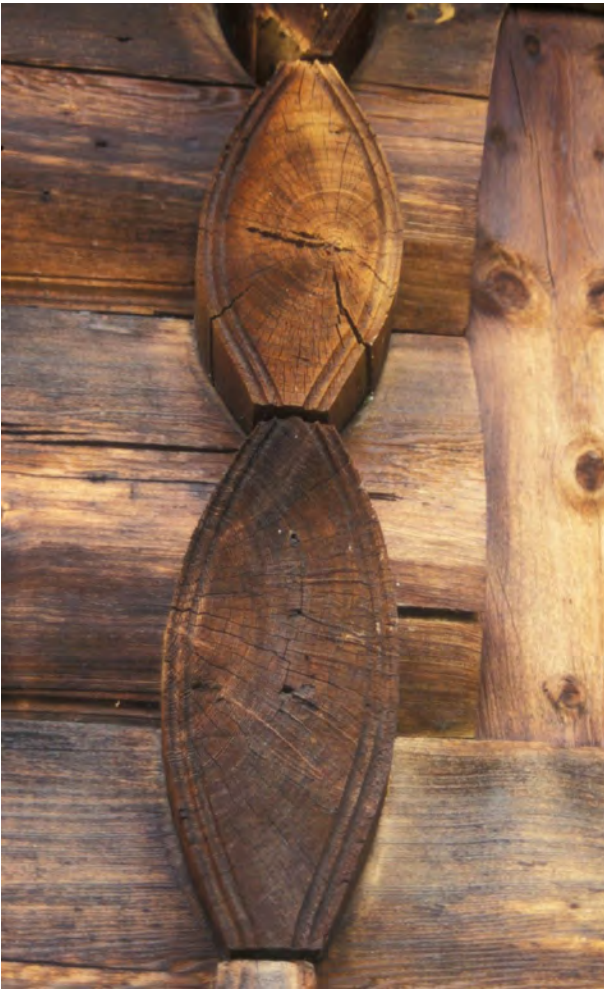
Figure 6.4 Detail of logs in a Norwegian log-structure from the late eighteenth century. Note the extremely narrow width of the annual rings

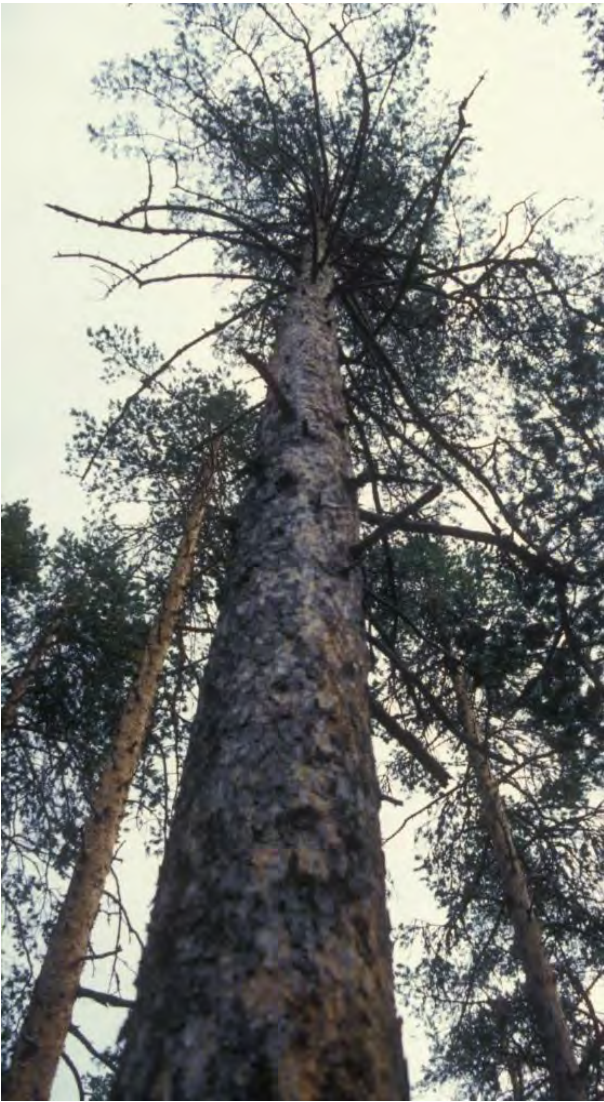
Figure 6.5 A straight-grown pine to be felled by the carpenter, selected on the basis of its bark and straight growth, making it suitable for cleaving.

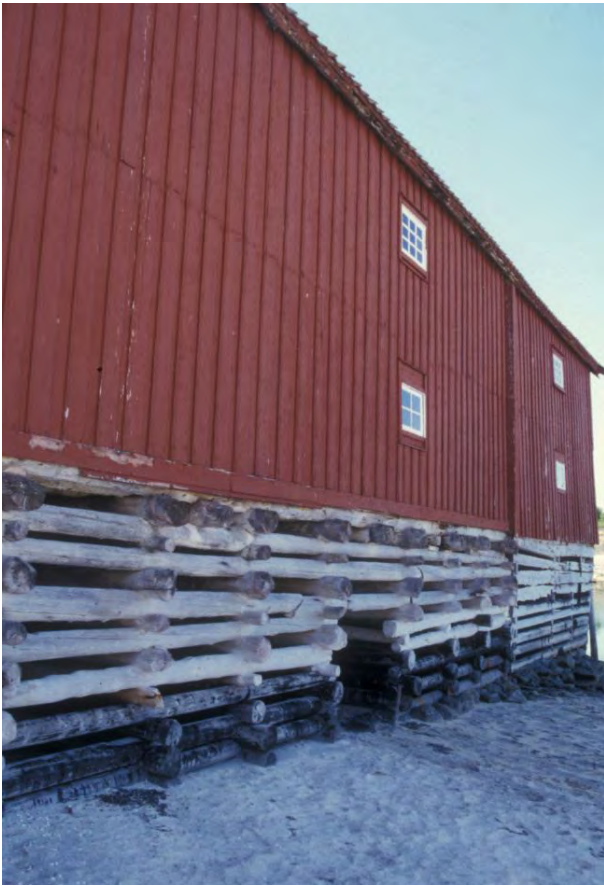
Figure 7.1 (a) A warehouse at Kjerringøy, Norway from the early nineteenth century. Salt fish had been stored here for years. This led to salt erosion of the timber in the foundations. (b) Detail of salt-eroded timber.

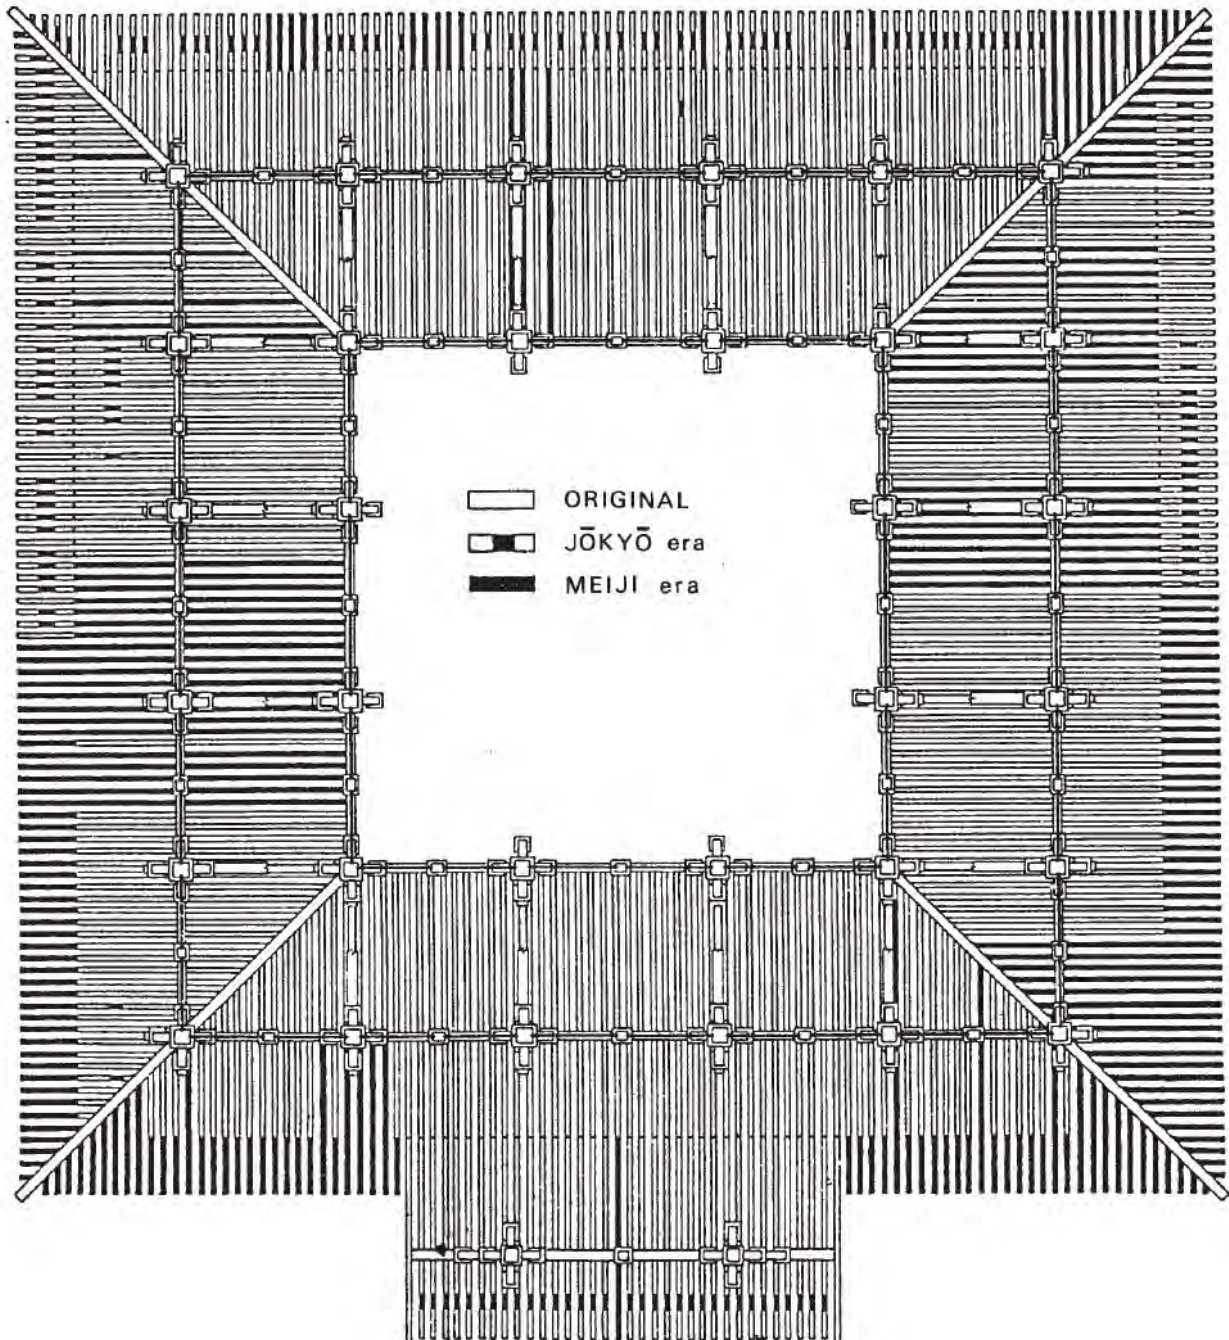
Figure 7.2 This drawing shows a plan of the rafters seen from below in the *Jōgyōdō* hall of the Enryaku-ji Buddhist temple in Shiga, Japan. The hall was built in 1595. The drawing shows the original members, and members added during repairs in the late seventeenth and late nineteenth century. (Drawing from *Juyo bunkazai Enryakuji jogyodo oyobi hokkedo shuri koji hokokusho*. Shiga Prefecture Board of education. 1968.)

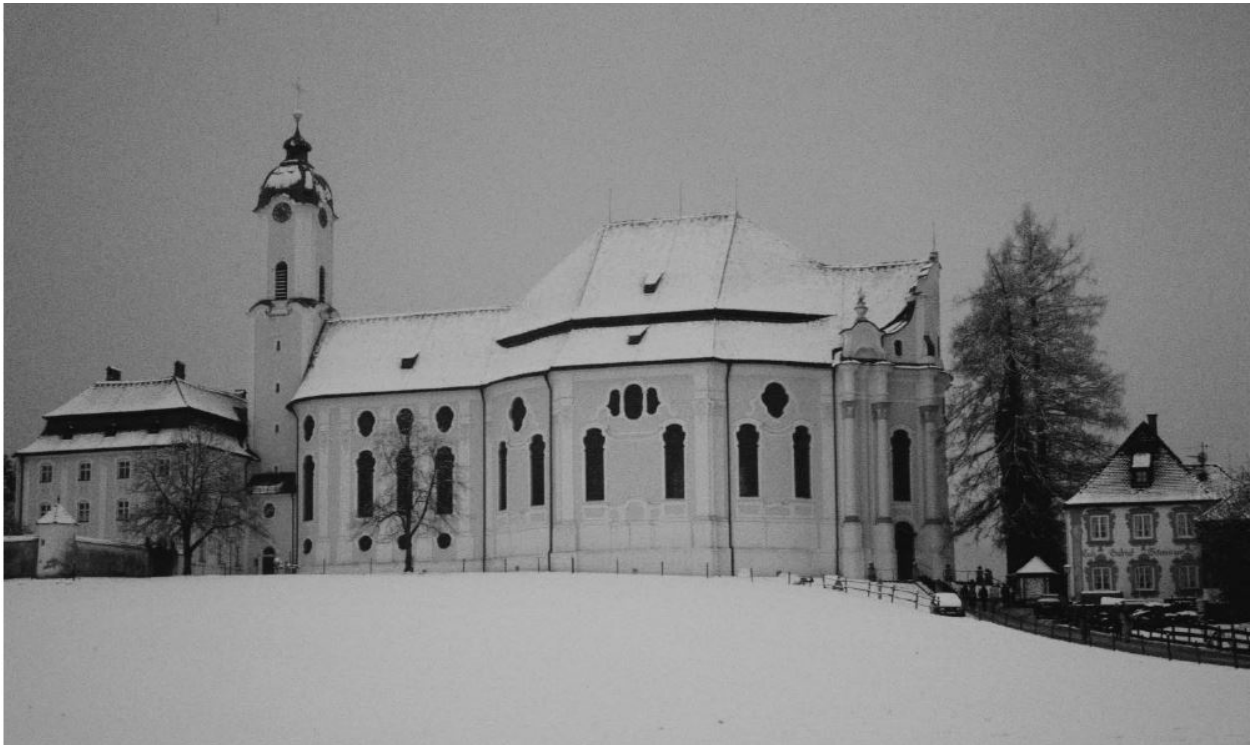
Figure 7.4 The pilgrimage church of Wies near Steingaden, Bavaria is a World Heritage site. It was built between 1745 and 1754. The church, situated in an alpine valley, is a masterpiece of rococo art and architecture. The masonry church walls and eight paired pillars carry a timbered roof structure and a wooden vault over the central area (the nave). The vault consists of ribs suspended in the roof structure, a construction typical of baroque churches. Laths are nailed to the ribs. The vault soffit is plastered and painted with beautiful frescoes. As the vault is linked to the roof structure, all forces affecting the roof, such as wind, consequently affect the vault and its stucco decorations.

Damages linked to frequent flights of military aircraft over the church in 1984 led to the church being closed out of concern for the safety of visitors. However, due to extensive inspection and comprehensive analysis of the structure and its history, the Bavarian State Conservation Office realised that it was not necessary to intervene in the delicate roof structure. Instead a system of monitoring was established. The structure could be conserved as it was, on the condition that a plan for future regular inspections was implemented.

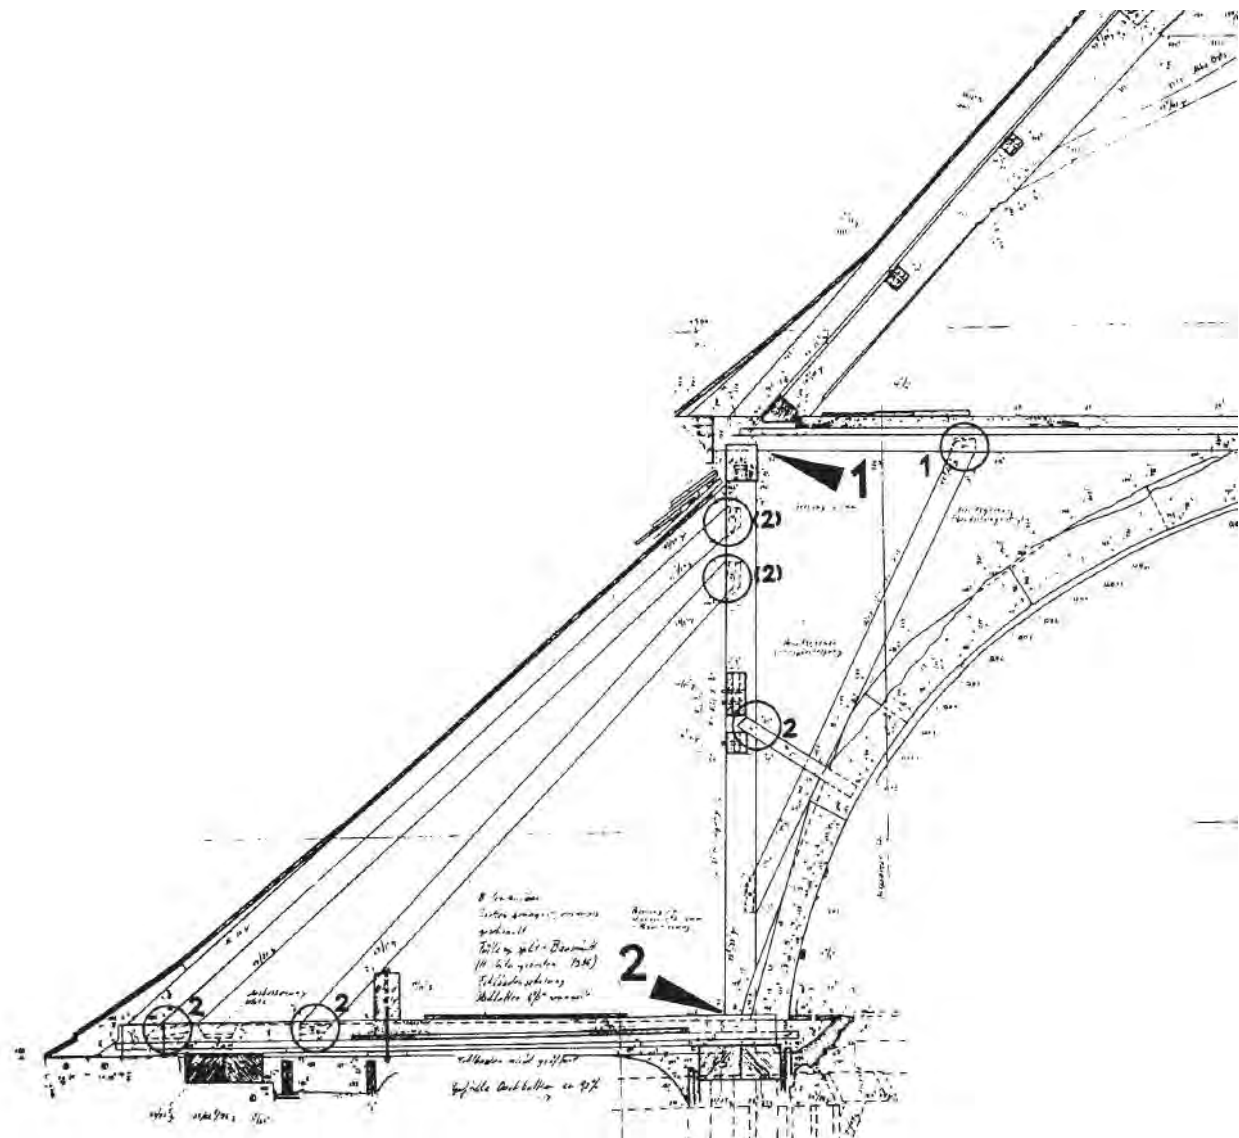
Figure 7.5 Wies church in Bavaria. Section of the roof. (Drawing from *Die Wies. Geschichte und Restaurierung*. Bayerisches Landesamt für Denkmalpflege, Arbeitsheft 55. München, 1992; p. 135.)

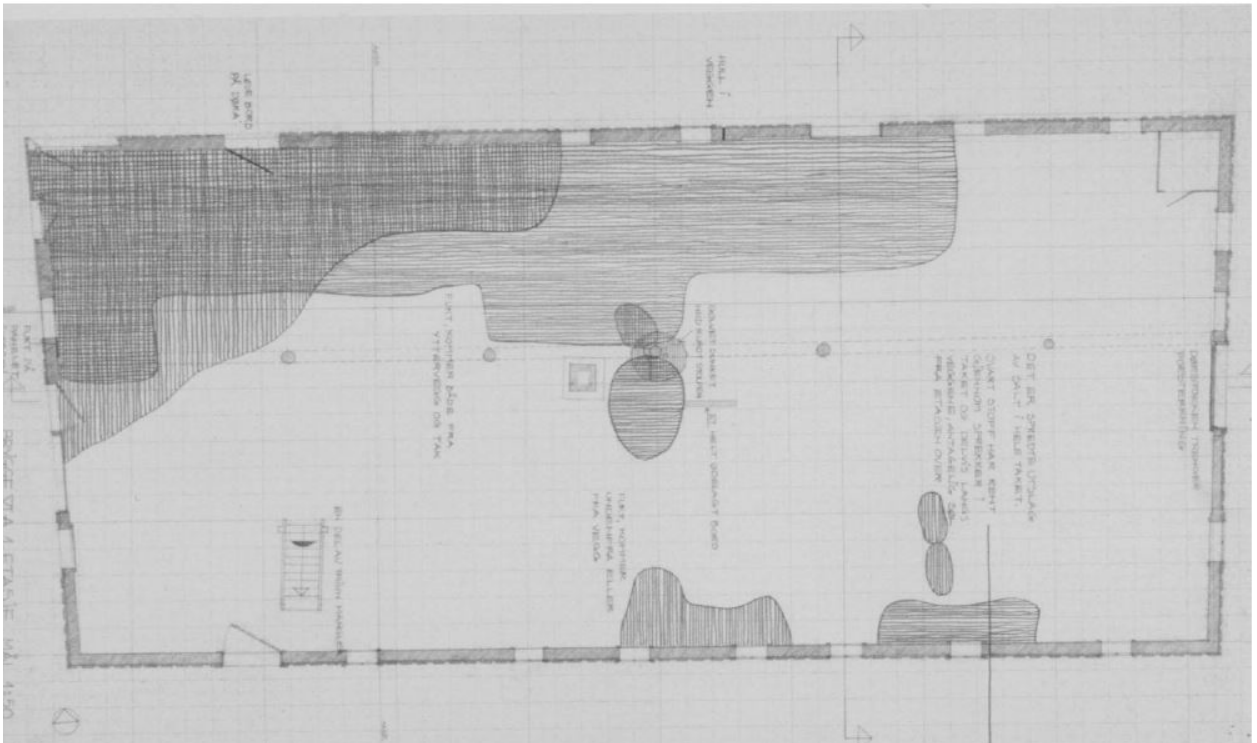
Figure 7.6 A measured drawing with decay and damage indicated.
