Conservation of Historic Timber Structures

An ecological approach

Knut Einar Larsen & Nils Marstein

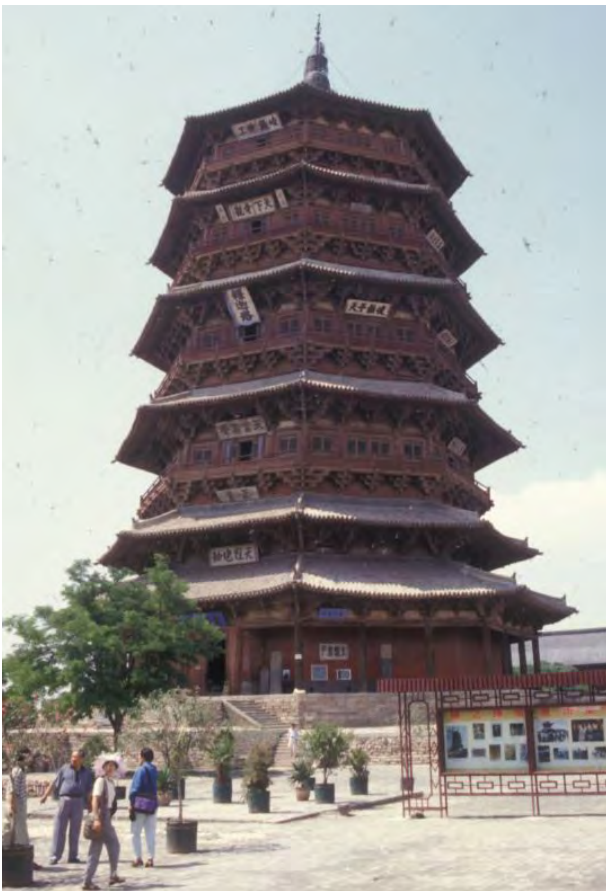
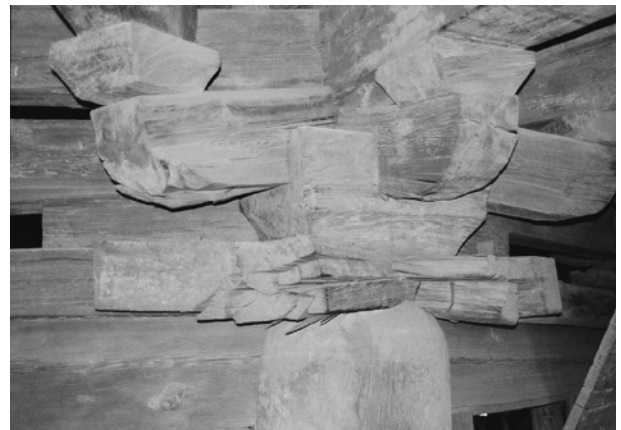
Figure 7.7 (a) The “Wooden Pagoda” of Fogong Temple in Yin county, Shanxi, China, built in 1056. The height of the pagoda is sixty-six metres, including the ten-metre high iron spire. (b) Wooden members which have been crushed due to the heavy weight of the pagoda.

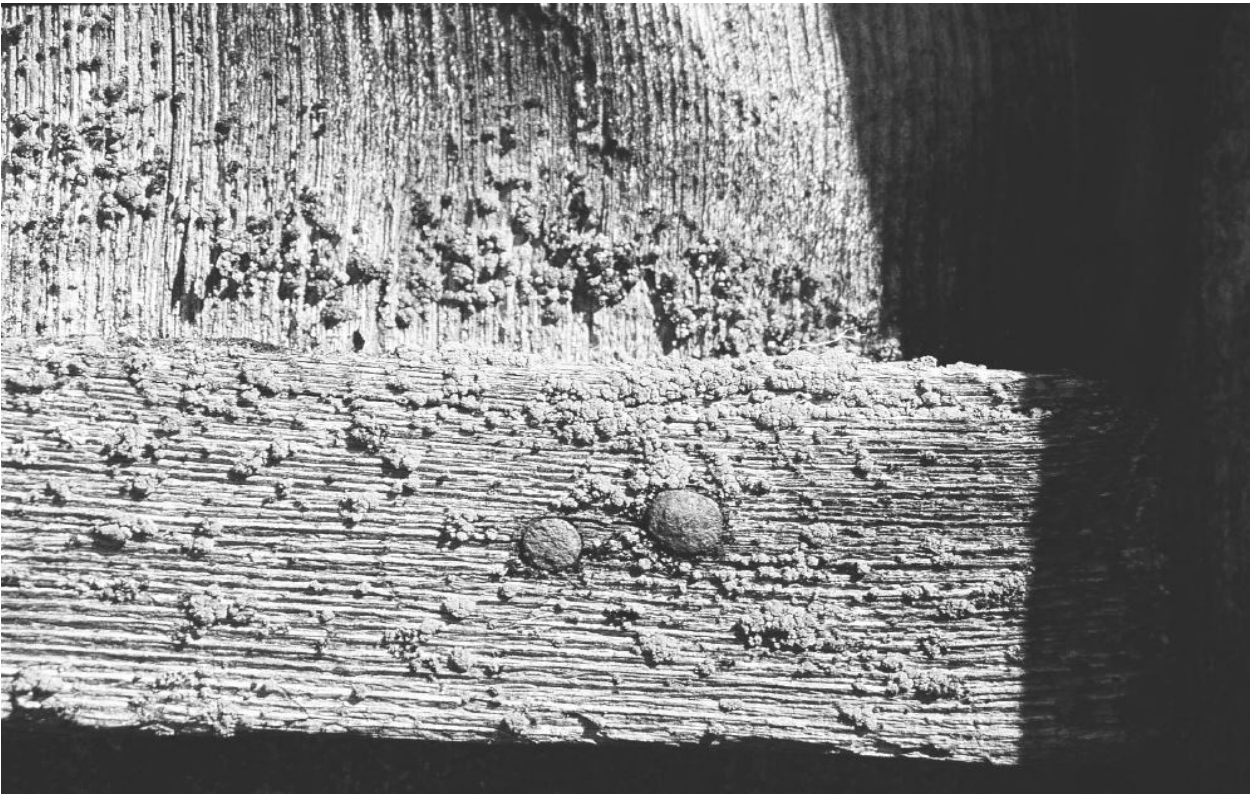
Figure 7.8 Lichen growing on the surface of timber exposed to the weather. This is not necessarily dangerous in itself, but large amounts of lichen may accumulate humidity and create conditions for fungal decay.

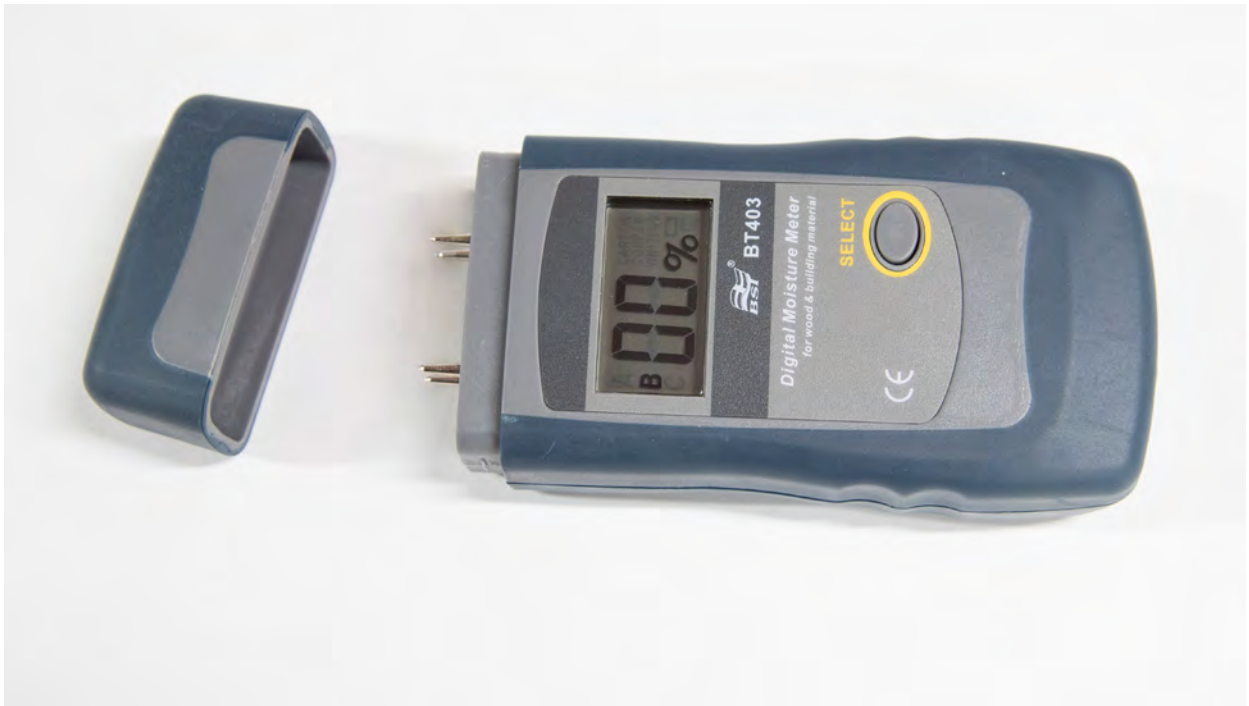
Figure 7.9 A moisture meter.

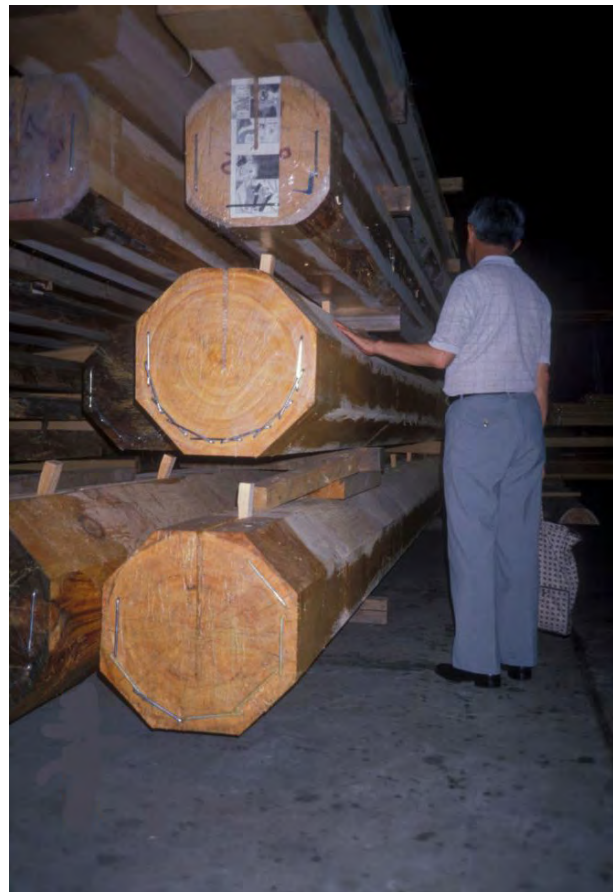
Figure 7.10 From a sawmill in Sakurai city, Nara, Japan. This sawmill specializes in Japanese cypress (*Chamaecyparis obtusa*). The ends of each log are waxed to stabilize the humidity inside the wood. Cramps are inserted into the ends to avoid cracking.

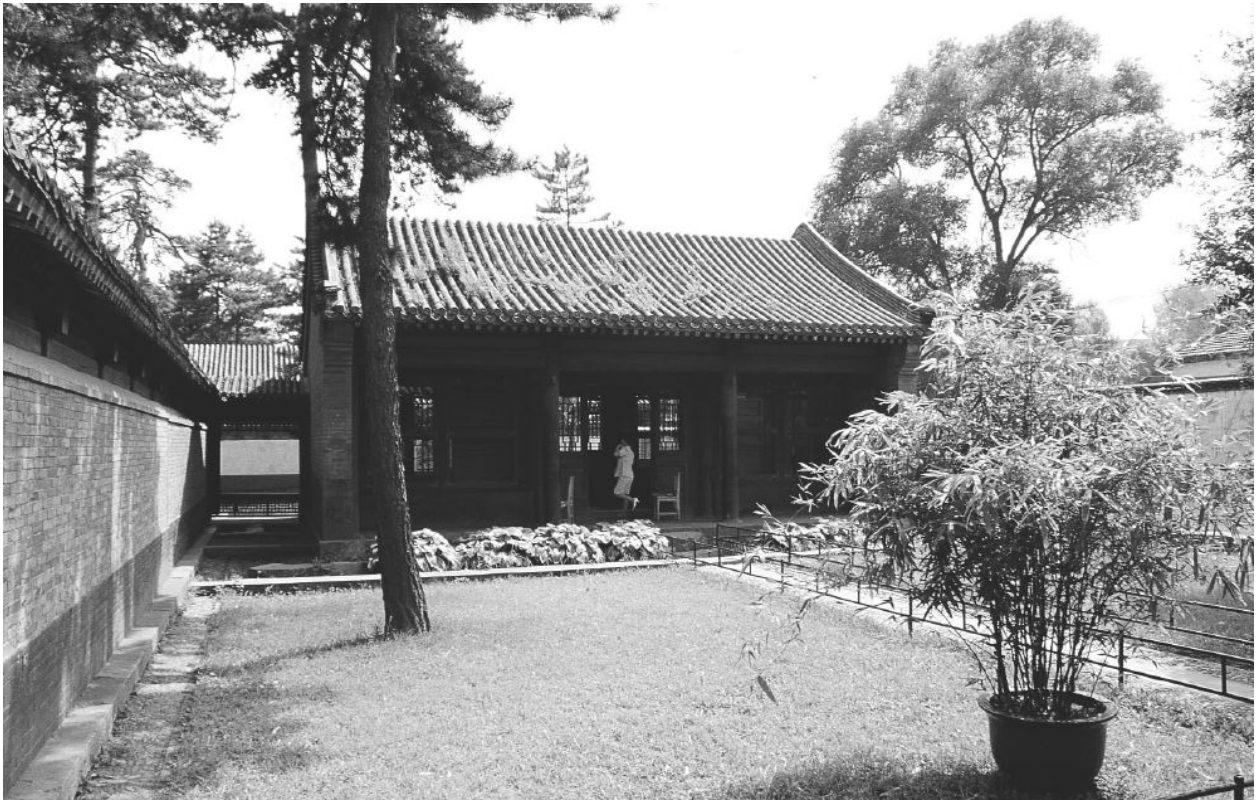
Figure 7.11 The Mountain Resort, Chengde, China, a World Heritage site. Small trees are growing on the roof of the building in the background. It is a part of the site management plan to remove growth from the roofs every three years. The removal is necessary for the long-term protection of the roof timber structure and tile roofing. The roof in this picture had been cleaned one year previously.

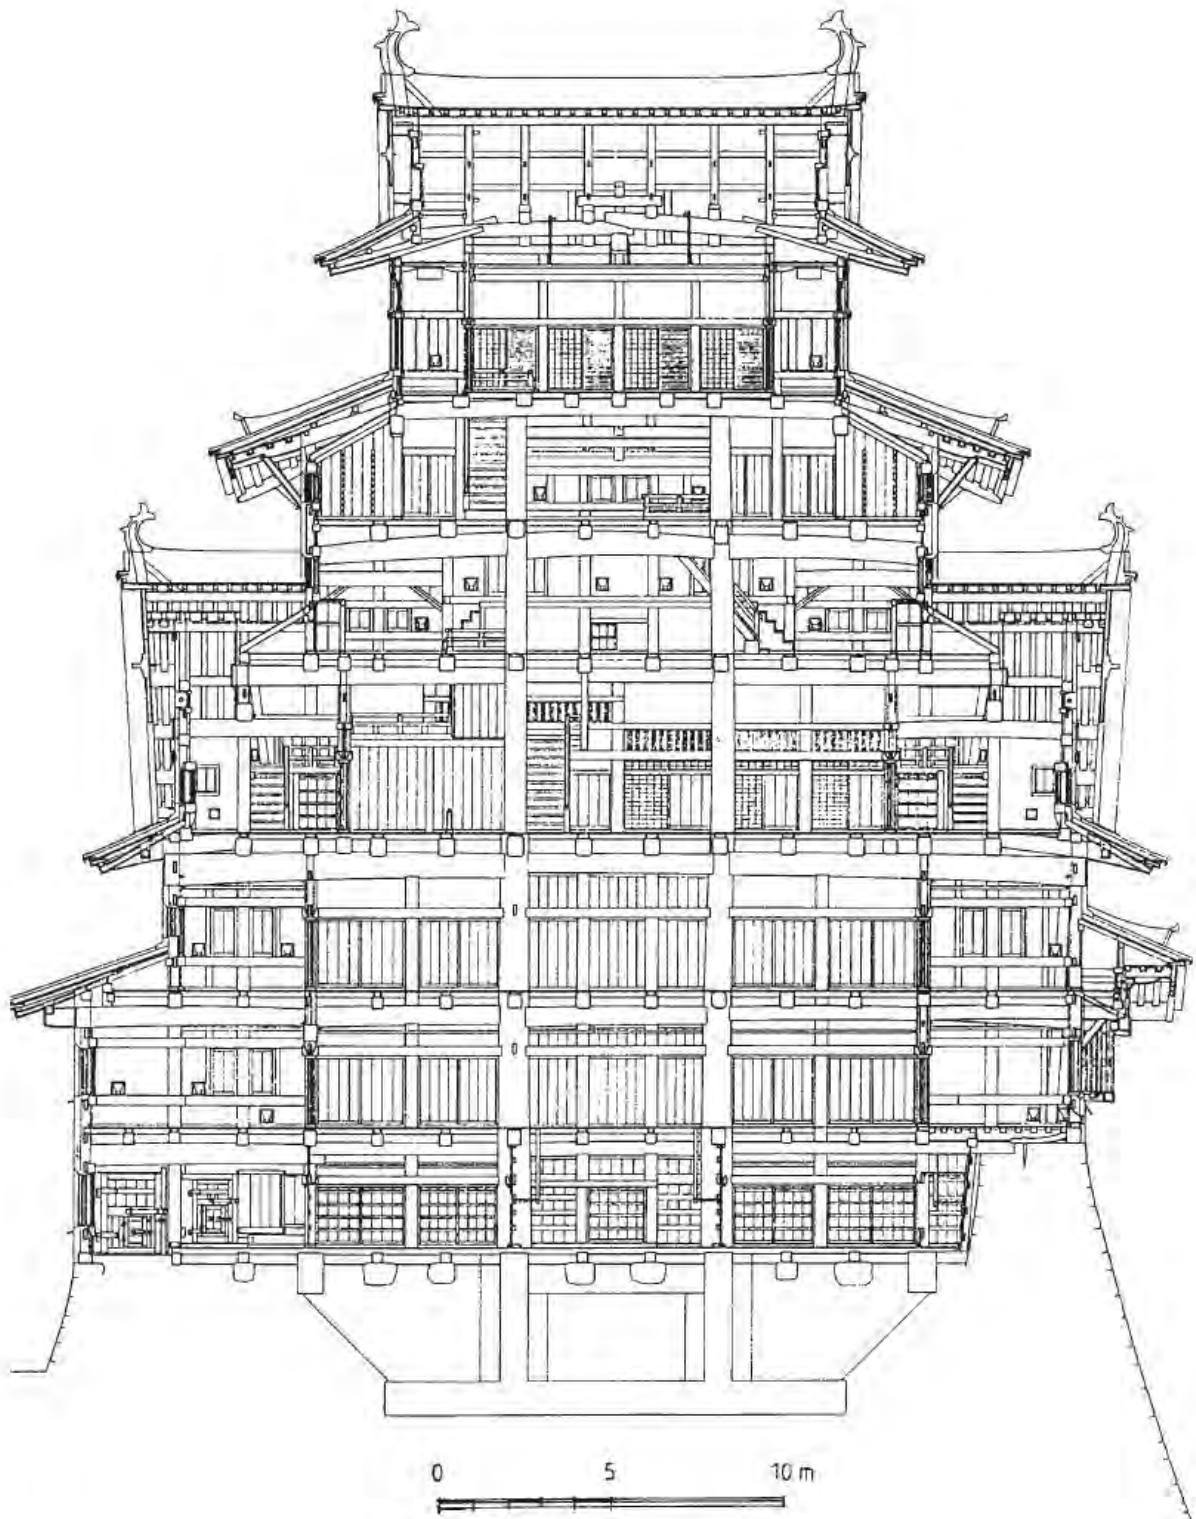
Figure 7.12 Himeji castle, Japan, a World Heritage site, built in the early seventeenth century. Section. This is a timber structure with external plastering. (Drawing from *Kokuho Himeji-jo hozon shuri koji hokokusho*. Vol 6: *Tenshu*. Agency for Cultural Affairs, Japan. 1965.)

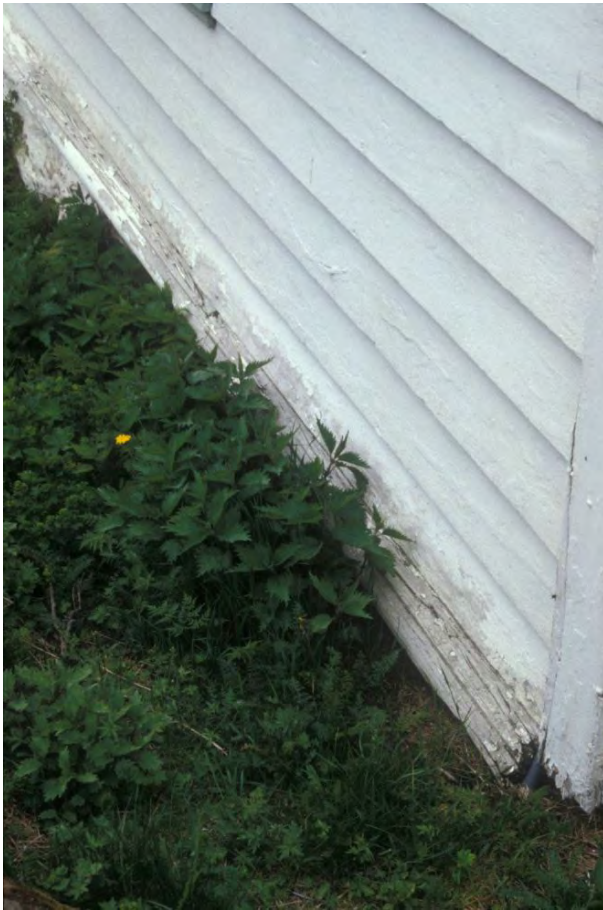
Figure 7.13 Grass growing along wooden walls accumulates moisture and leads to decay.

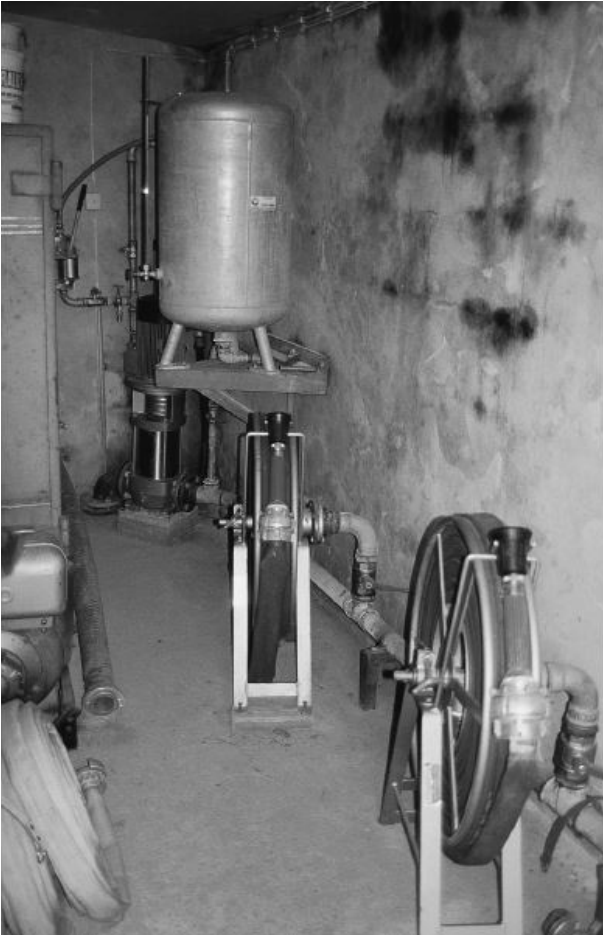
Figure 7.14 Fire protection equipment at a Norwegian farm where there are a number of listed buildings. The owner has created a small pond to provide water for the fire fighting equipment.

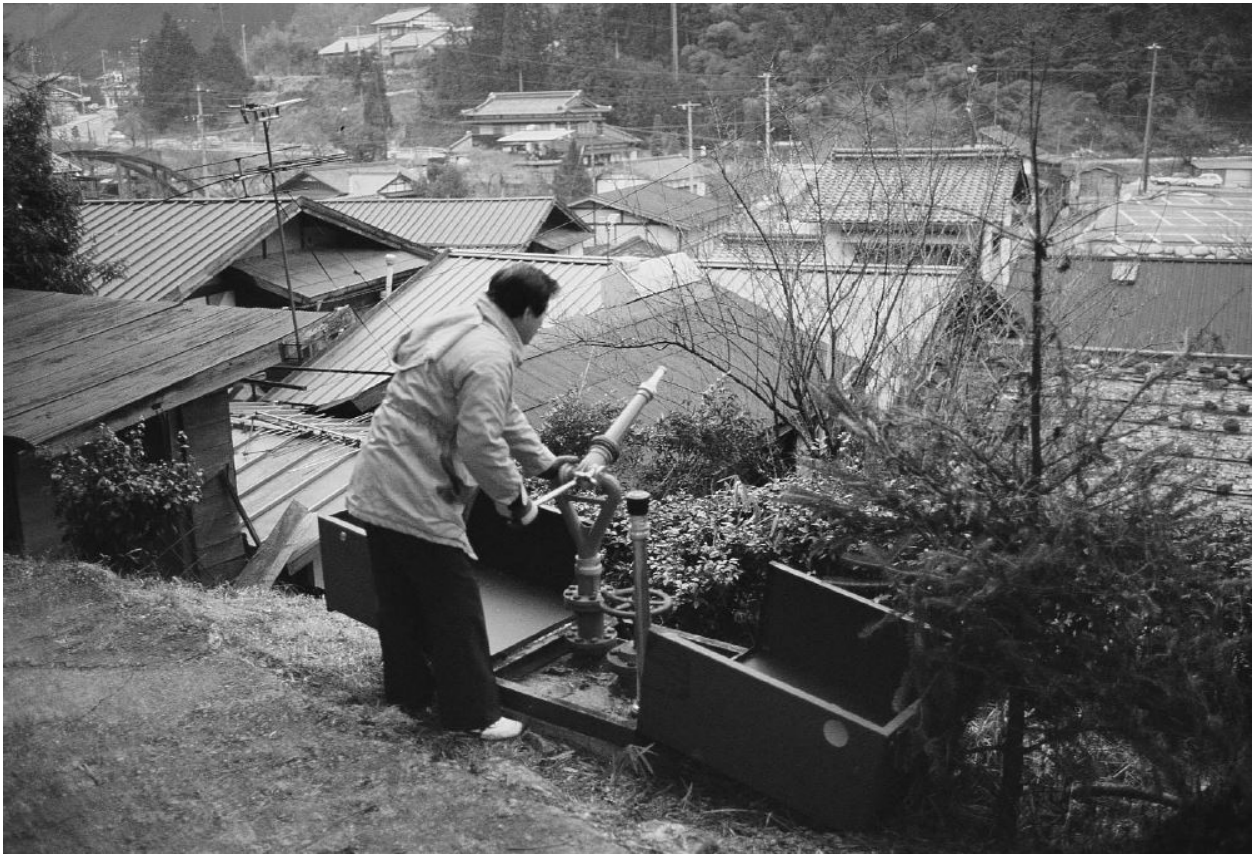
Figure 7.15 Demonstrating the use of a water gun in Tsumago town, Nagano, Japan. Tsumago is an historic post-town designated as a preservation district.

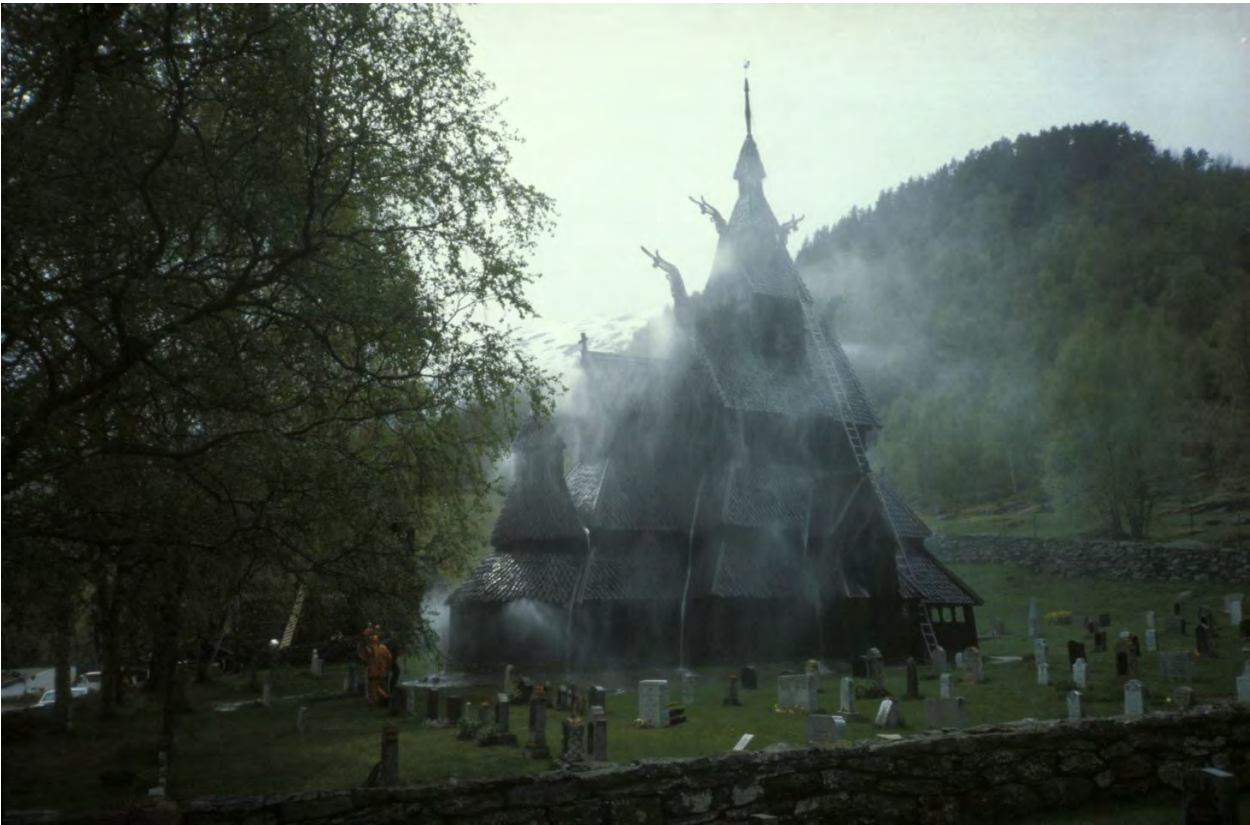
Figure 7.16 Borgund stave church, Sogn, Norway, during a sprinkler fire extinguishing system test in 1982. All the 28 medieval stave churches have fire detection and fire extinguishing systems. Traditional sprinkler systems and advanced mist systems are used.

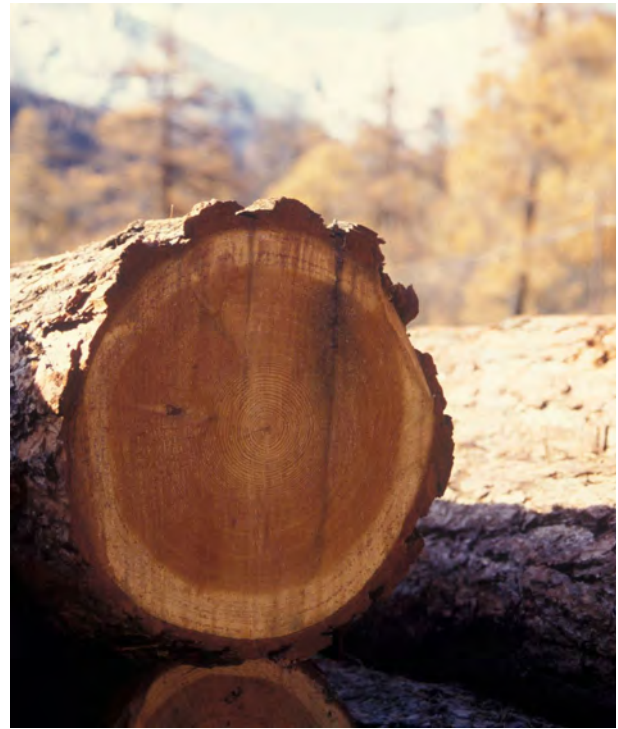
Figure 8.2 The end section of a larch log (*Larix decidua*). The heartwood covers almost the whole cross-section; there is only a narrow outer ring of sapwood.

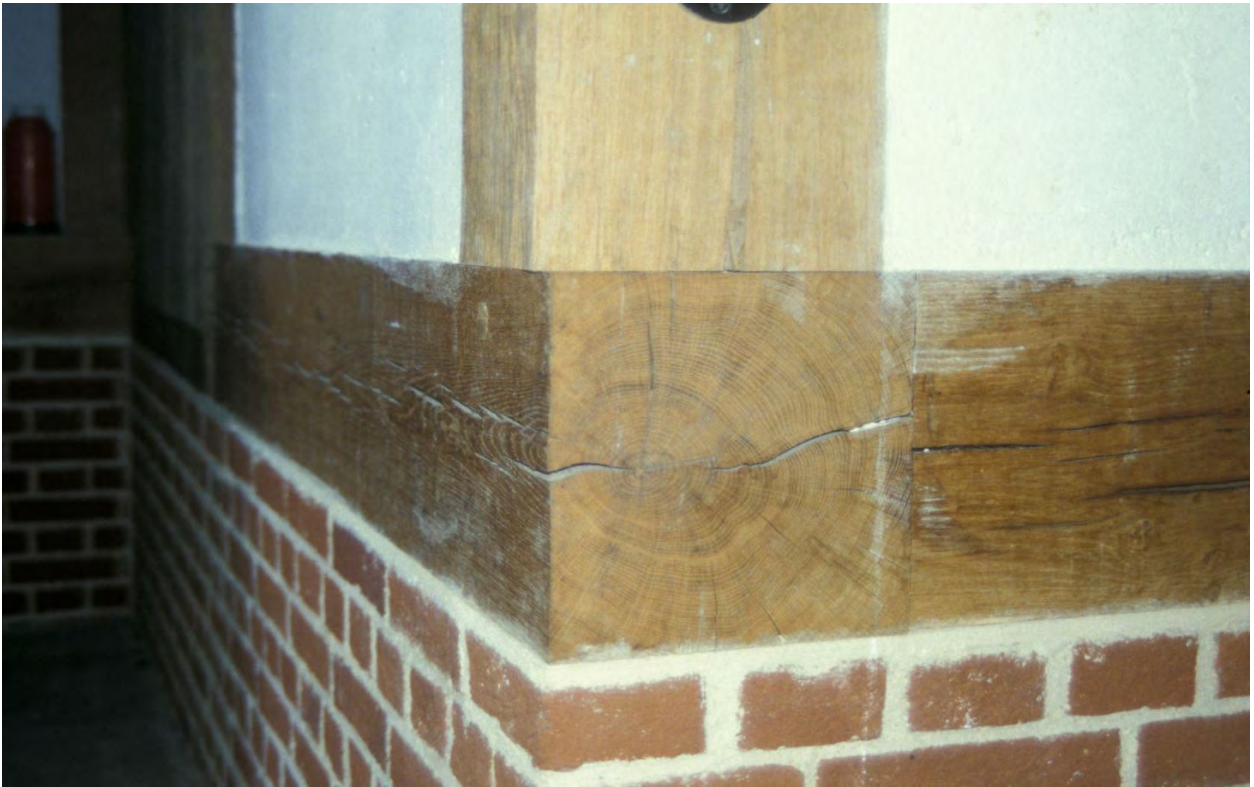
Figure 8.3 Shakespeare's Globe, London (1997). Oak heartwood (*Quercus robur*) was used in all external (exposed) members, although the architect and builder Peter McCurdy reckoned that the original structure probably contained timber with a high proportion of sapwood.

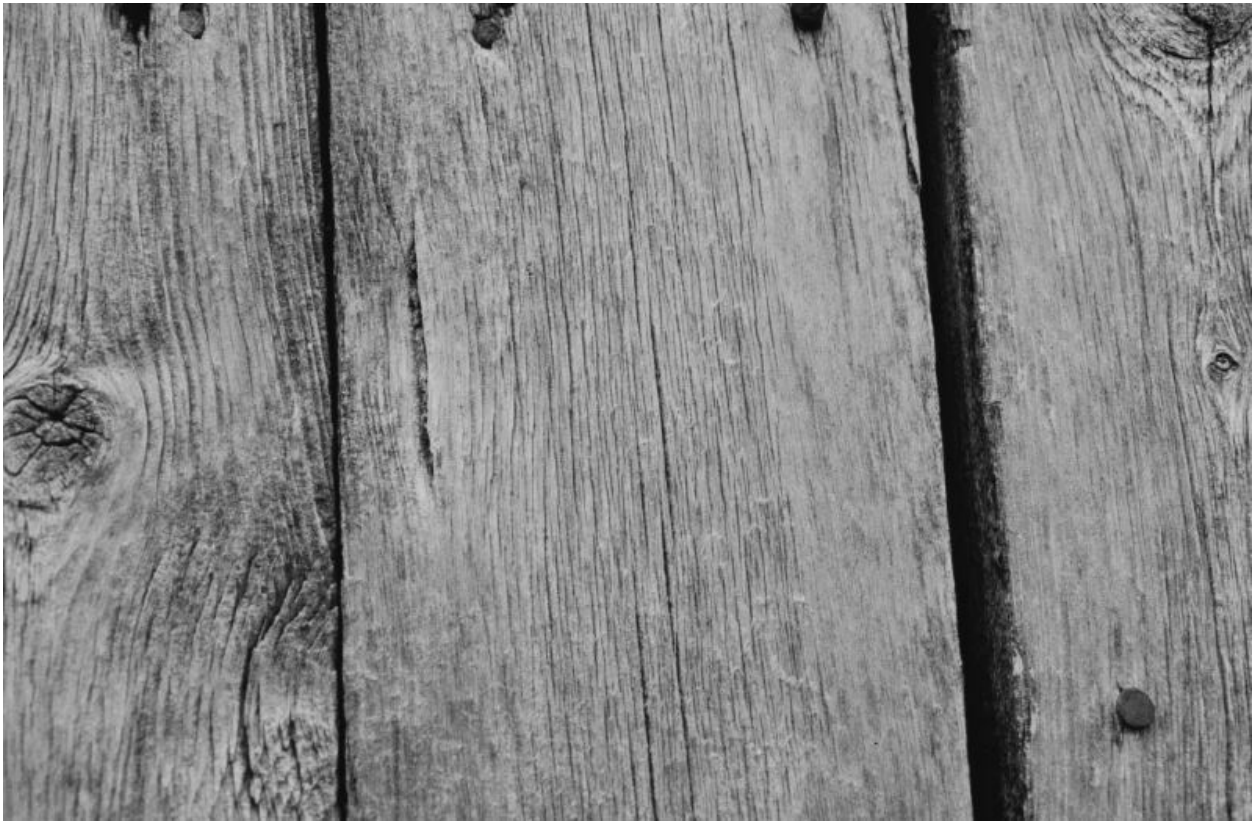
Figure 8.5 External boarding of aspen (*Populus tremula*), about 80 years old. This external boarding has never been treated with paint or coating. It is still in excellent condition, despite being on an exposed site.

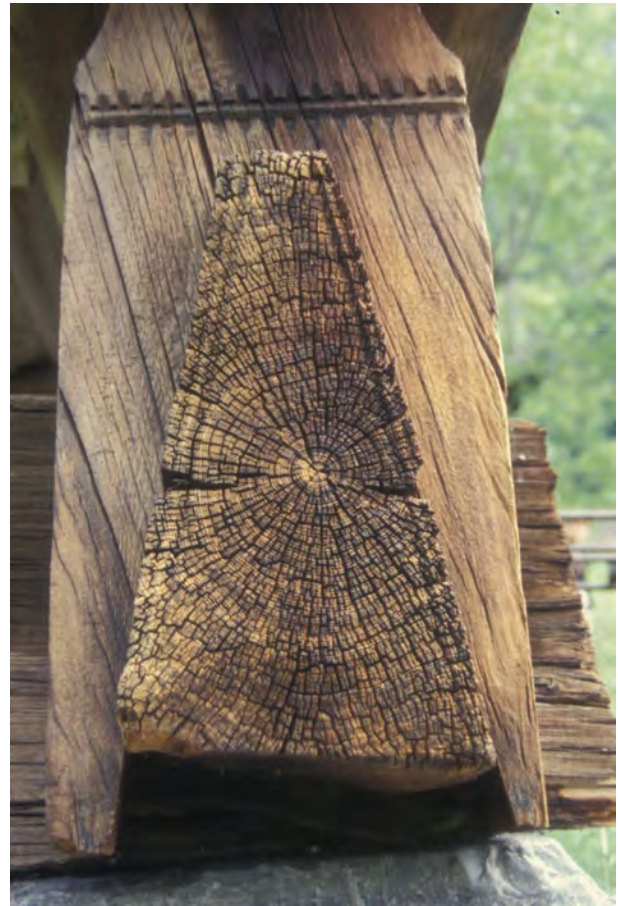
Figure 8.8 Detail of the sill-beam in a Norwegian log-structure from late eighteenth century. Note the extremely narrow width of the annual rings, and that the sapwood content is insignificant. It is very well preserved, despite exposure to the elements over two centuries.

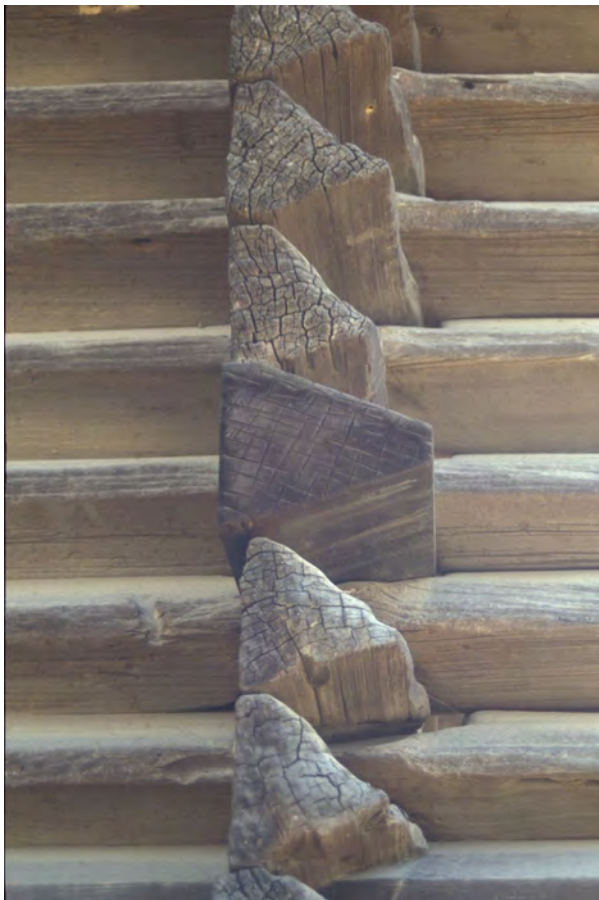
Figure 8.9 Detail from a log-structure from the Todai-ji temple in Nara, Japan, built in the eighth century (see Figure 3.8). The cross-section of the original eighth century logs has been greatly reduced due to weathering. The new log, clearly distinguishable, was added during repair completed in 1964.

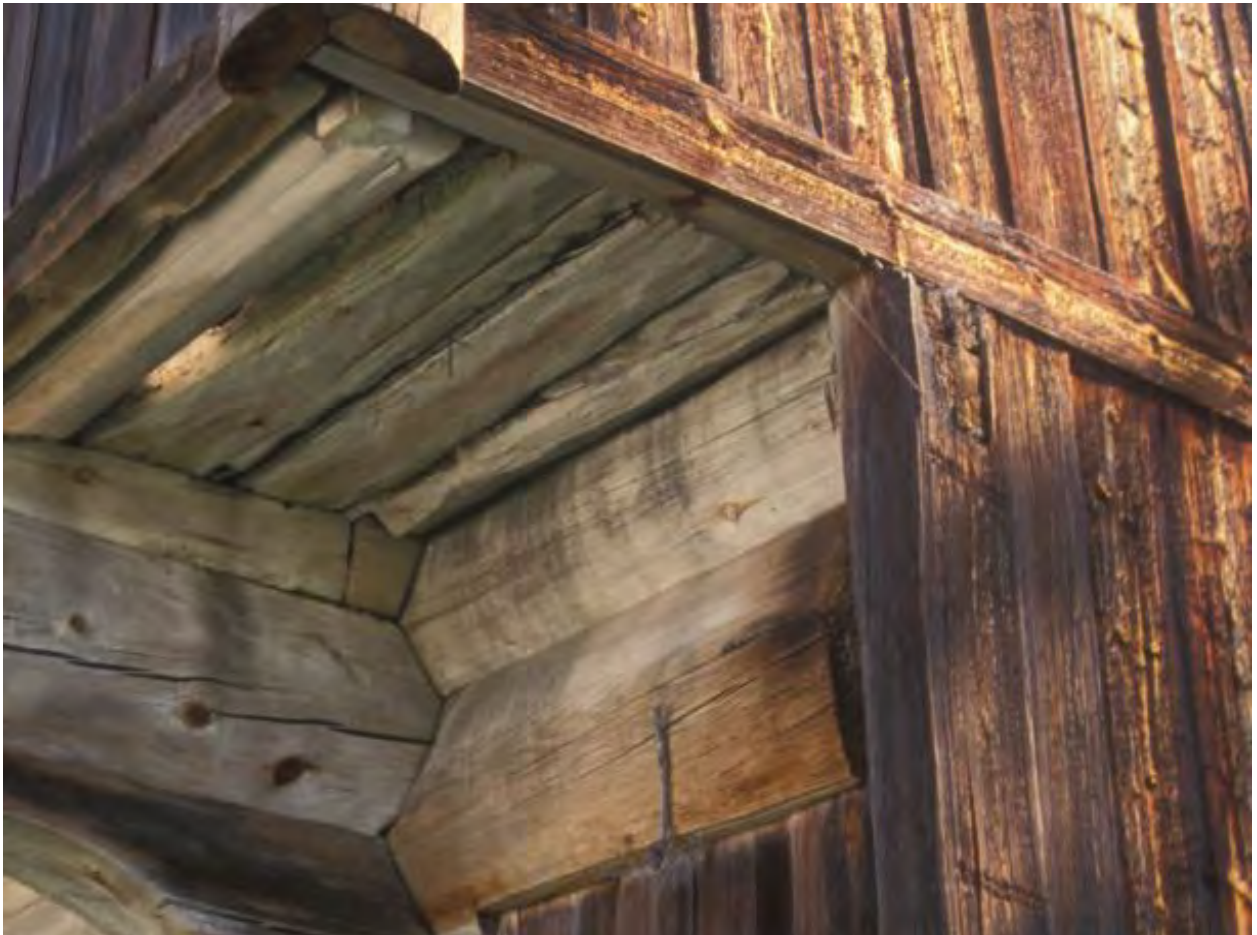
Figure 8.10 A medieval timber structure in Telemark, Norway. The medieval logs which have not been exposed to the weather are grey in colour and look like new timber. The external boarding which is secondary, is dark brown in colour and has eroded due to weathering.

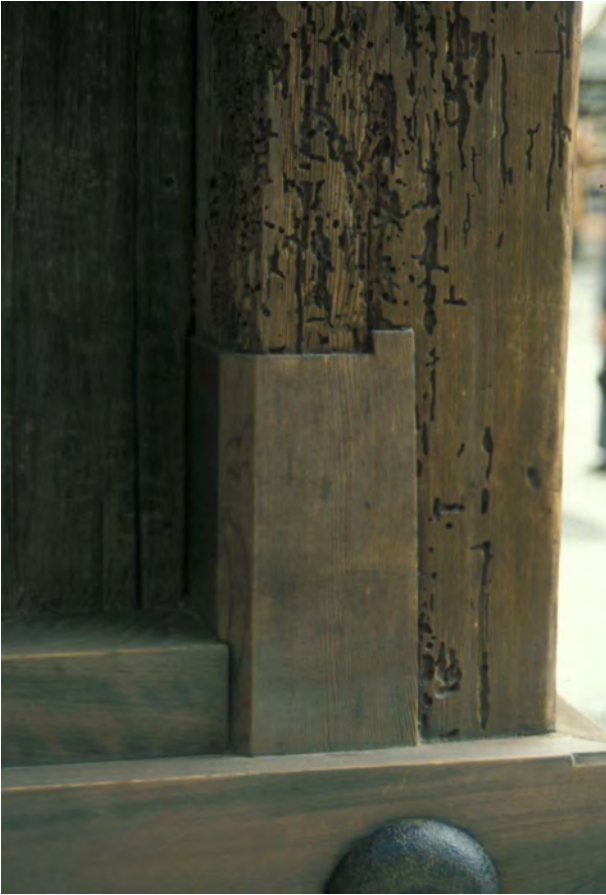
Figure 8.11 Detail of the *Shakadō* hall in the Kiyomizu-dera Buddhist temple, Kyoto, Japan, built in the eighteenth century. During the dismantling-repair process completed in 1975 the lower part of this corner pillar was repaired by jointing in new, well-seasoned timber. The new timber contrasts dramatically with the original timber, whose appearance is due to decay, insect attack and the effects of weathering.

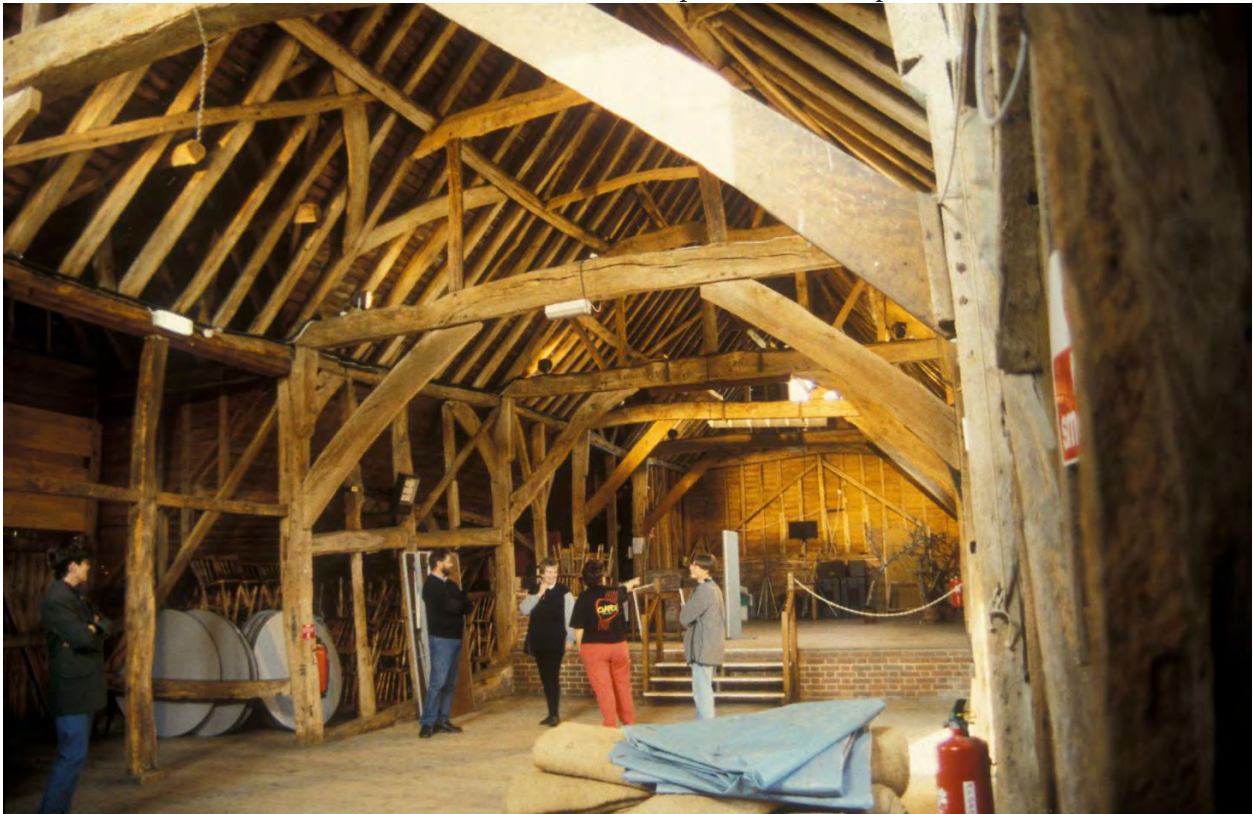
Figure 8.12 The Mayflower Barn, Jordans, Buckinghamshire. Tradition has it that this was constructed using old timbers from the Mayflower.

The use of old timber from other timber structures in repair work was quite common in days gone by. In repair work, however, the situation is different due to uncertainty about the physical and mechanical behaviour of old timbers. Most experts warn against using timber from another structure in the repair of timber-framed buildings (Charles 1984: 58; Boutwood 1991: 5; Brereton 1995: 27). This is not because of any possible reduction of the strength of the timber, but due to the moral and practical difficulties in re-using old timbers from other structures in repair or replacement work. The use of second-hand timber cannibalised from old structures should be avoided because it will be archaeologically misleading. From a practical perspective, old oak is rock-hard and may well destroy tools. Furthermore, finding an exact matching piece to fit into a timber frame is a problem in repair work. Second-hand timber brought in from

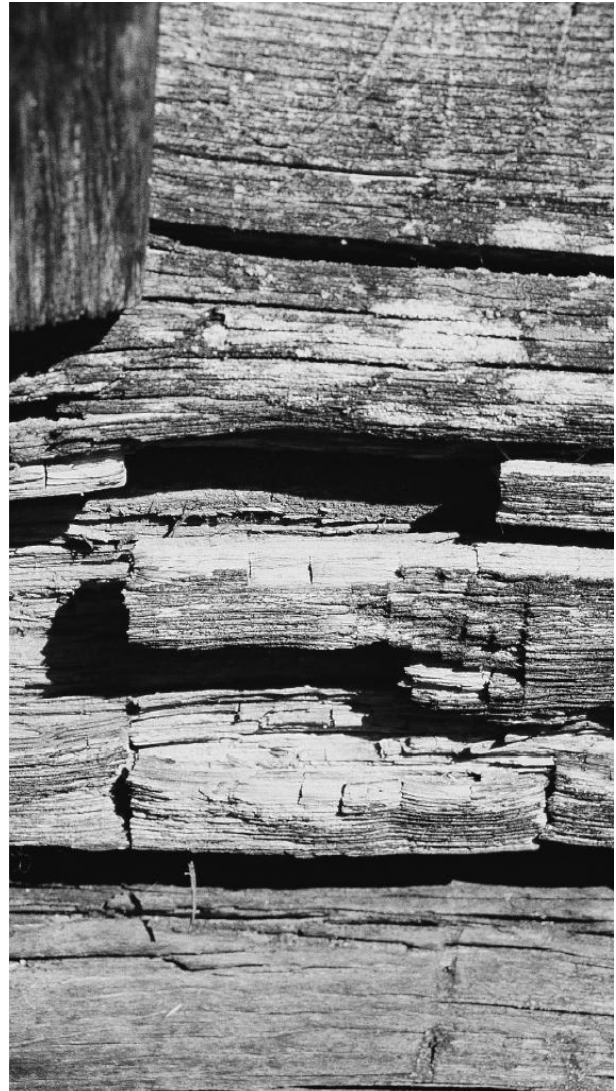
Figure 9.1 Brown rot showing typical cubical deterioration of wood.

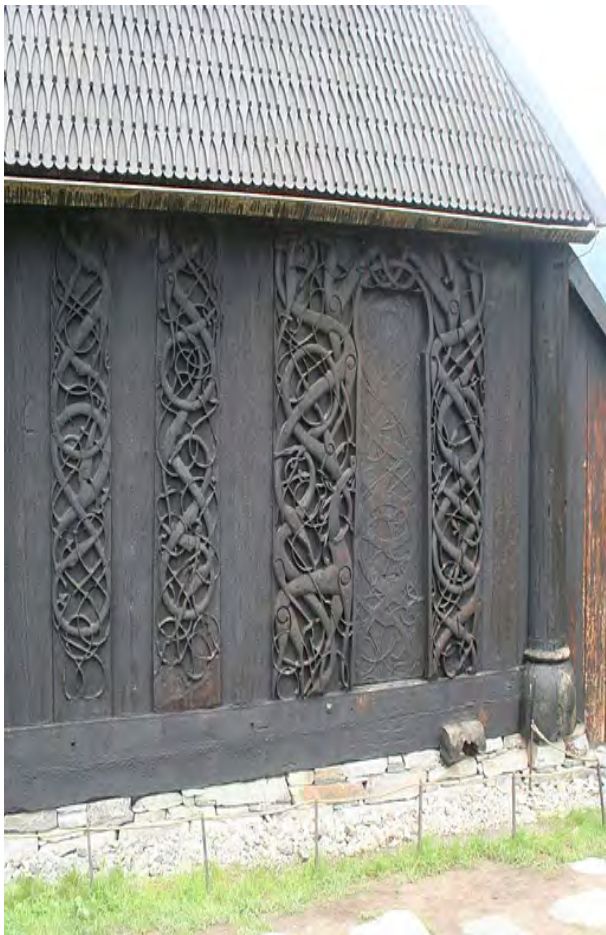
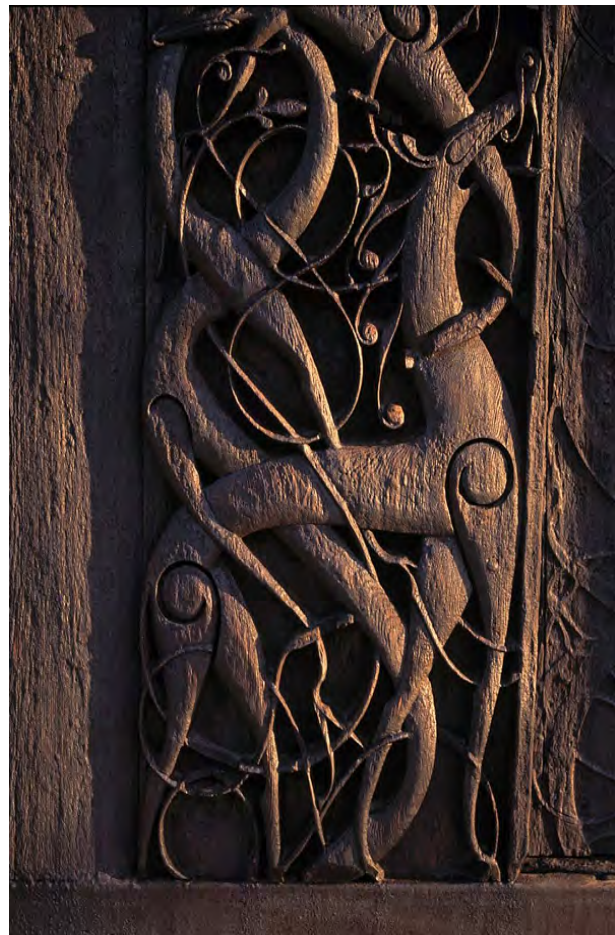
Figure 9.2 (a) Urnes stave church, Sognefjord, Norway, built 1150. The northern wall with carved elements from an earlier church on the same site. One of the reasons why the wall and these ancient carvings are so well preserved is that the wall has continuously been protected using traditionally-distilled pine tar. (b) Urnes stave church. Detail of an eleventh century carving.

In Norway, the use of traditionally-distilled pine tar goes back to the Viking period (ninth to tenth centuries) when the Vikings used it to protect their ships. Pine tar was, and still is, made by burning pine stumps and root stocks and extracting the distillation product. From the Middle Ages up until the beginning of the twentieth century the use of pine tar was restricted to the protection of churches, since it was both time-consuming and expensive to produce. This goes a long way towards explaining why outdoor woodwork on the stave churches from the twelfth century which has been protected with pine tar is preserved in an excellent condition. Norwegian church accounts reveal that the local farmers and villagers were obliged to apply fresh tar to the external walls of the stave churches at ten-yearly intervals.

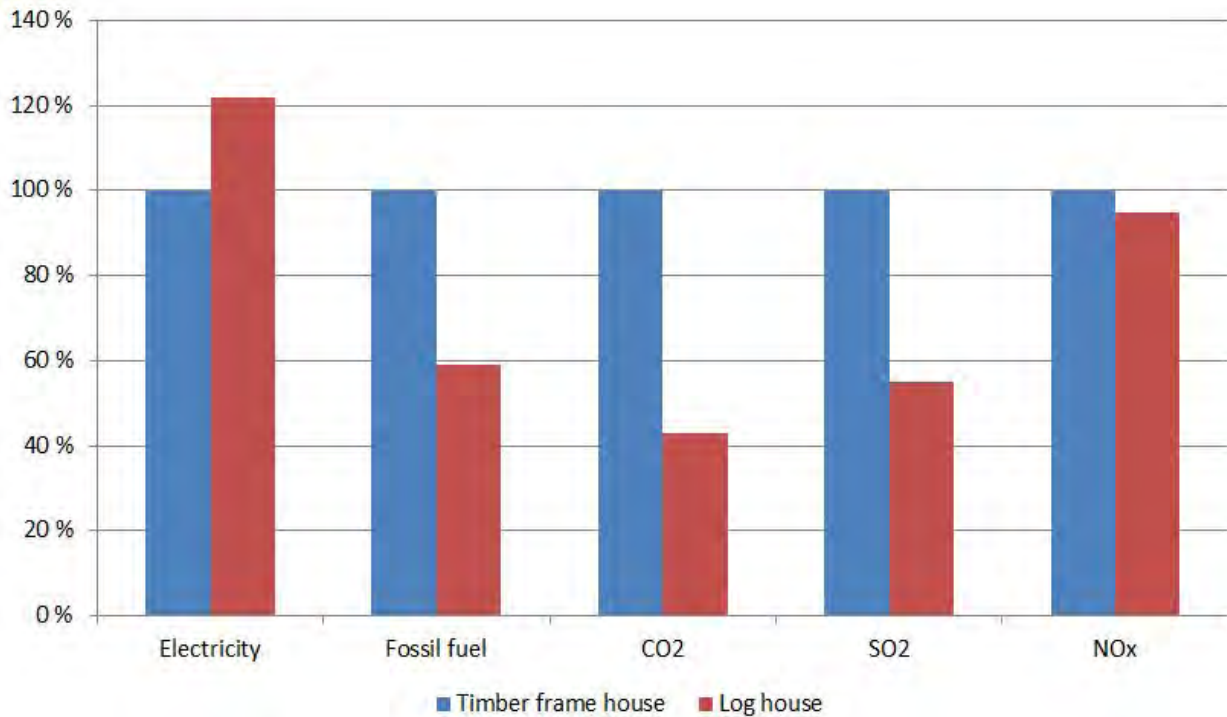
Figure 10.4 Normalised consumption and emissions for the timber frame and the log house. (After Fossdal and Edvardsen 1995).

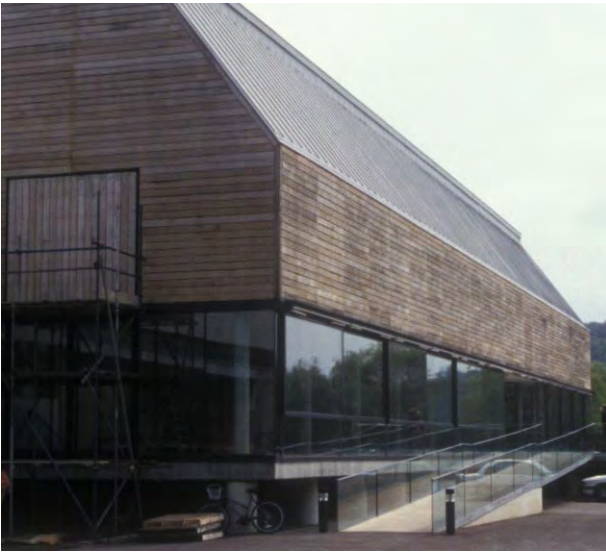
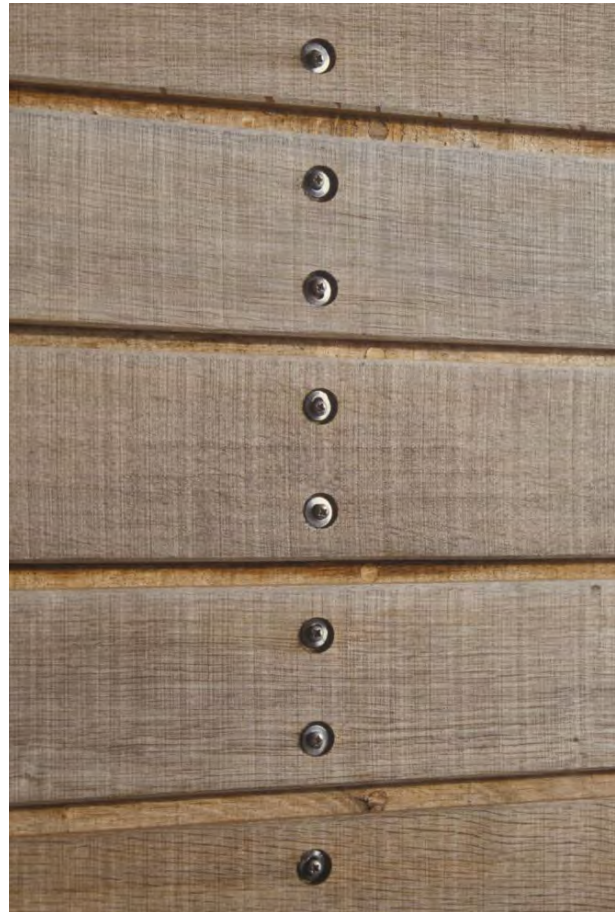
Figure 10.5 (a) River and Rowing Museum, Henley, England. Architect David Chipperfield (1996). The green-oak cladding was carefully selected for economy and durability. (b) Detail.
